Case study  
on the restoration  
of the  
1735 Richard Bridge Organ  
at  
Christ Church Spitalfields

Manual & Pedal Soundboards

**WILLIAM DRAKE Ltd**  
Organ Builder  
Chapel Street, Buckfastleigh, Devon TQ11 0AB

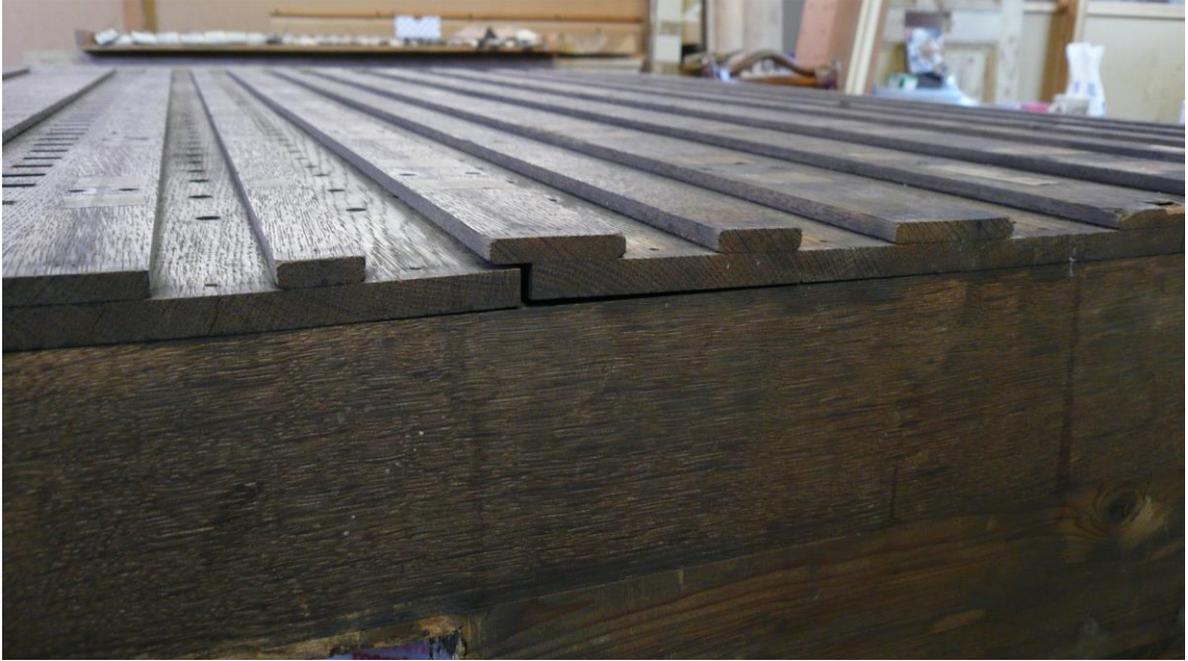
Due to the condition of the glue the tables had come away from the soundboard grids over about 75% of the total surface.

The condition of the table of the treble Great soundboard showing the table having come away from the grid

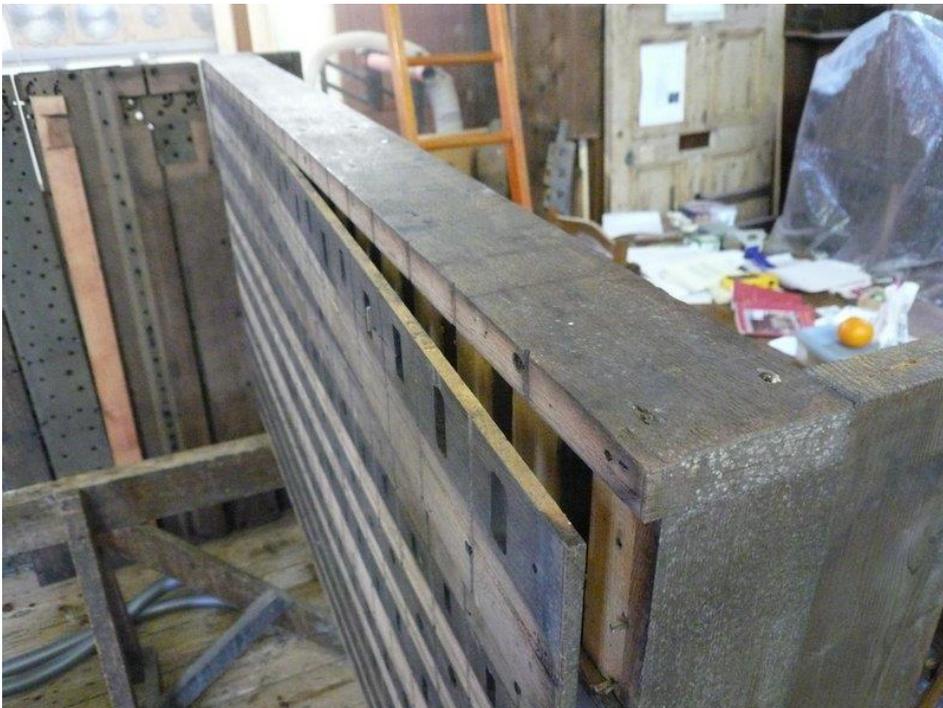
The detached table of the treble Choir soundboard

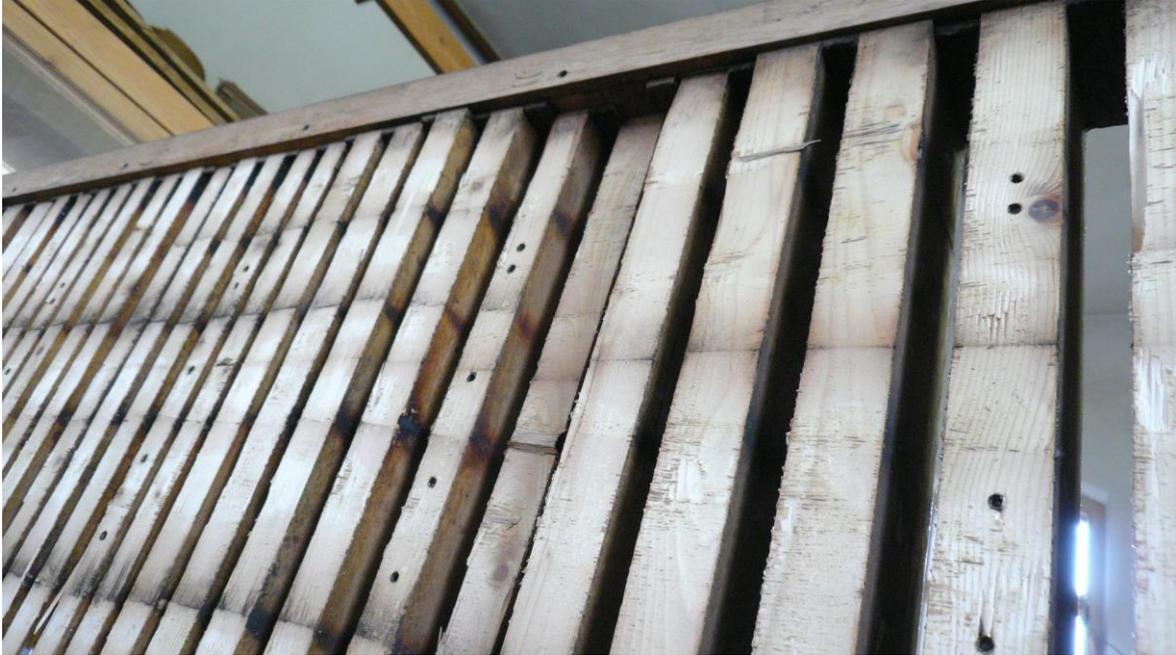
The bars and outer rails making up the grid had become detached from each other, causing the bottom and top surfaces to be very uneven.

The soundboard first dismantled had little structural integrity left after removal of the table

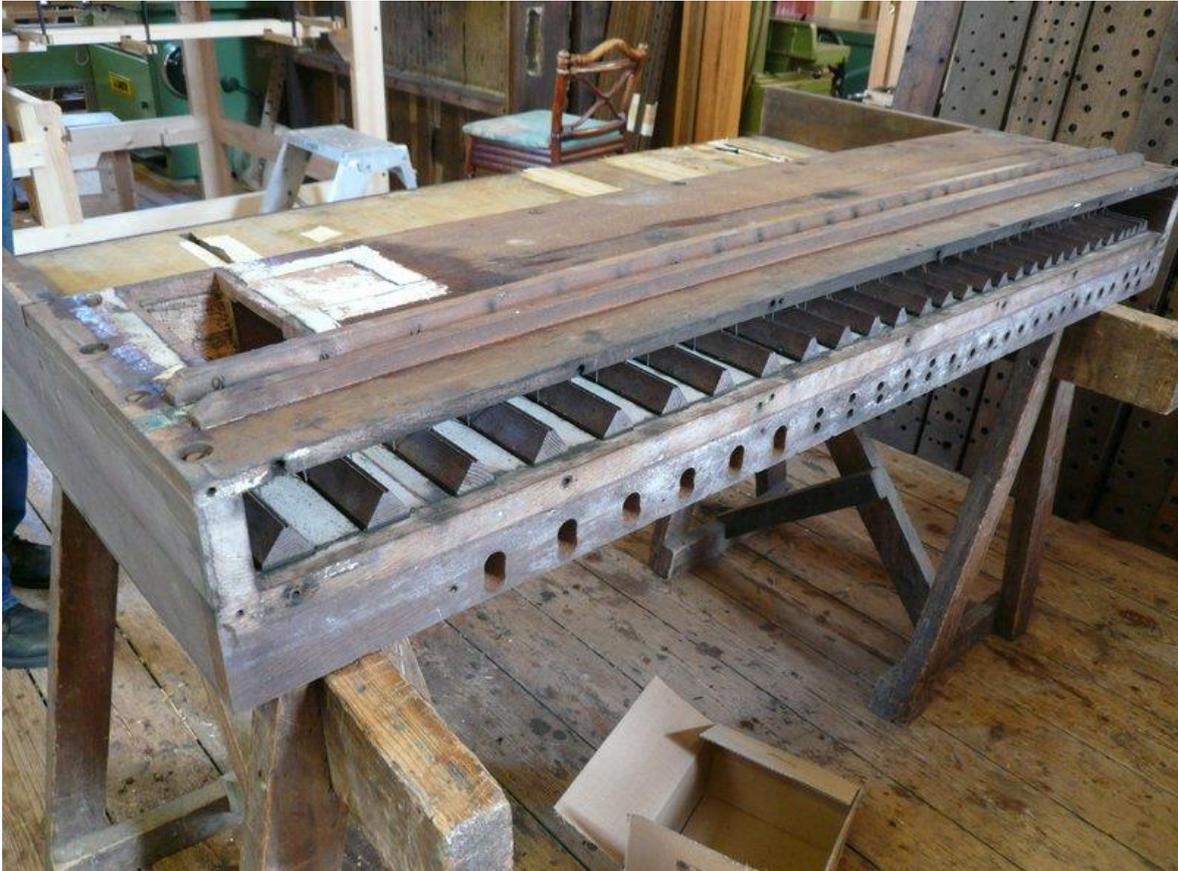
The oak front rails of the Choir grids had been drilled to take a side-slider which was added by Gray & Davison. The drilling of these holes had severely damaged the fillers glued against the inside between the bars.

The drilled front rail of the grid (note the battens holding the brass strip on the bottom board)

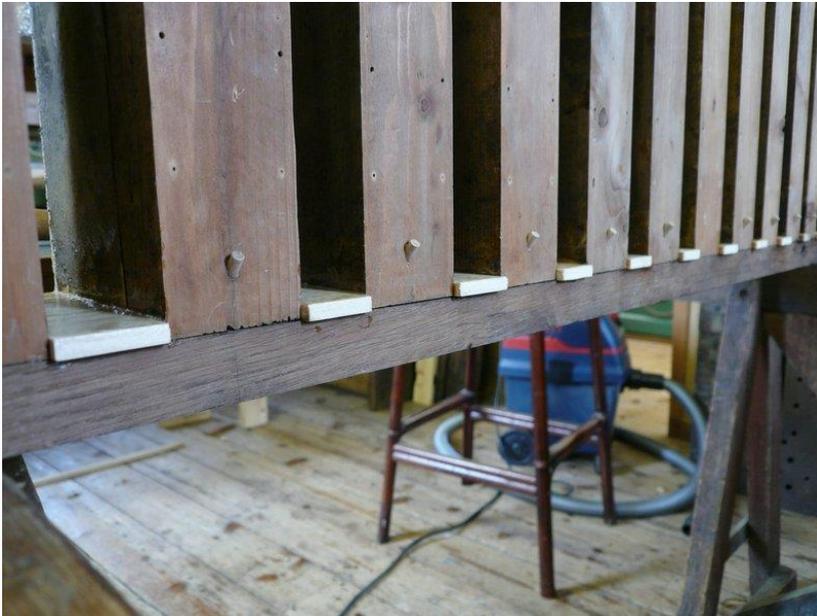
Stabilising dowels and new fillings-in glued in

Holes for 4mm dowels were drilled under an angle through the end of the correctly positioned bar into the rail on both sides of the grid, top and bottom side. These were injected with hot animal glue and dowels were hammered in.

Keeping in mind that the organ would have to function in a building with modern heating standards, It was eventually decided that the fillers would be replaced with new ones, again of pine, with the grain corresponding to the length of the rails instead of across it. The holes in the front rails were plugged with appropriate size oak plugs.

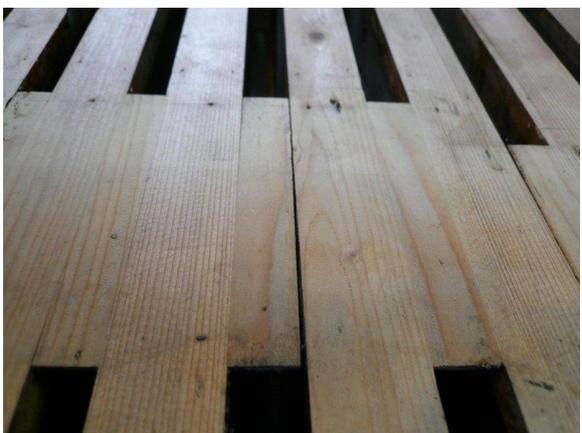
Evidence of significant shrinkage

The splits between the fillings-in under the pallet tails and the bars were repaired by splicing in pieces of pine. All repairs of this kind were done with the use of hot animal glue.

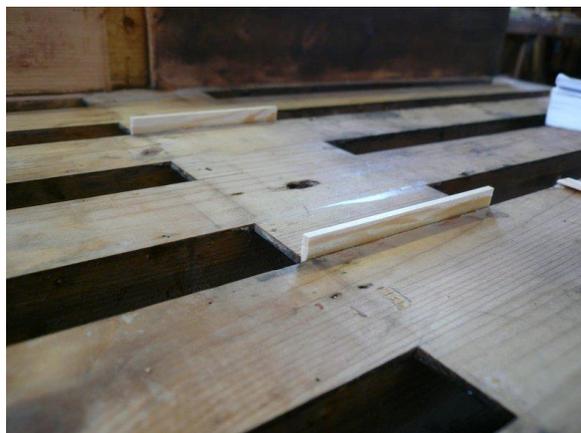
Repairs in progress

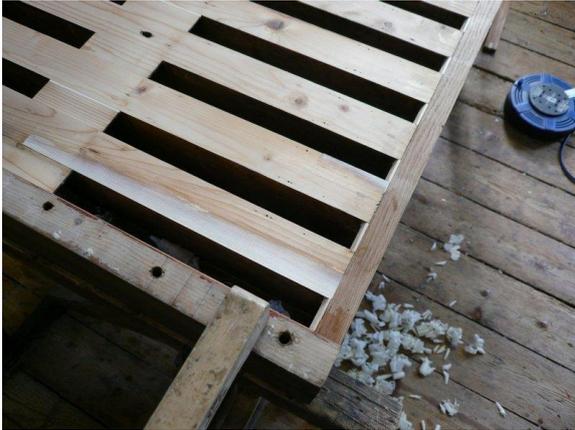
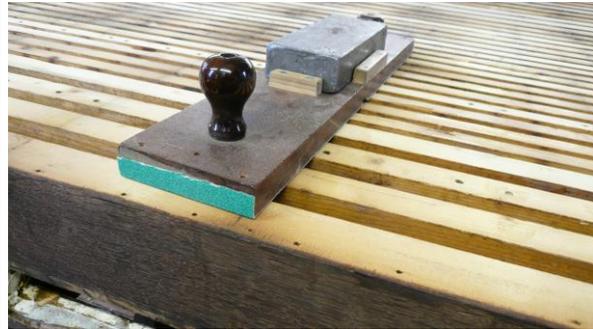
Levelling of the bars by glueing on veneers

The grid was now prepared for the re-application of the table. The surface of the bars had to be straightened into one flush surface on both sides. This was achieved with the help of a large hand plane and a weighted sanding block. Any bars which were too low under the surface were built up by glueing on veneers. This was done to minimise the loss of old material in the pursuit of a flat and level surface.

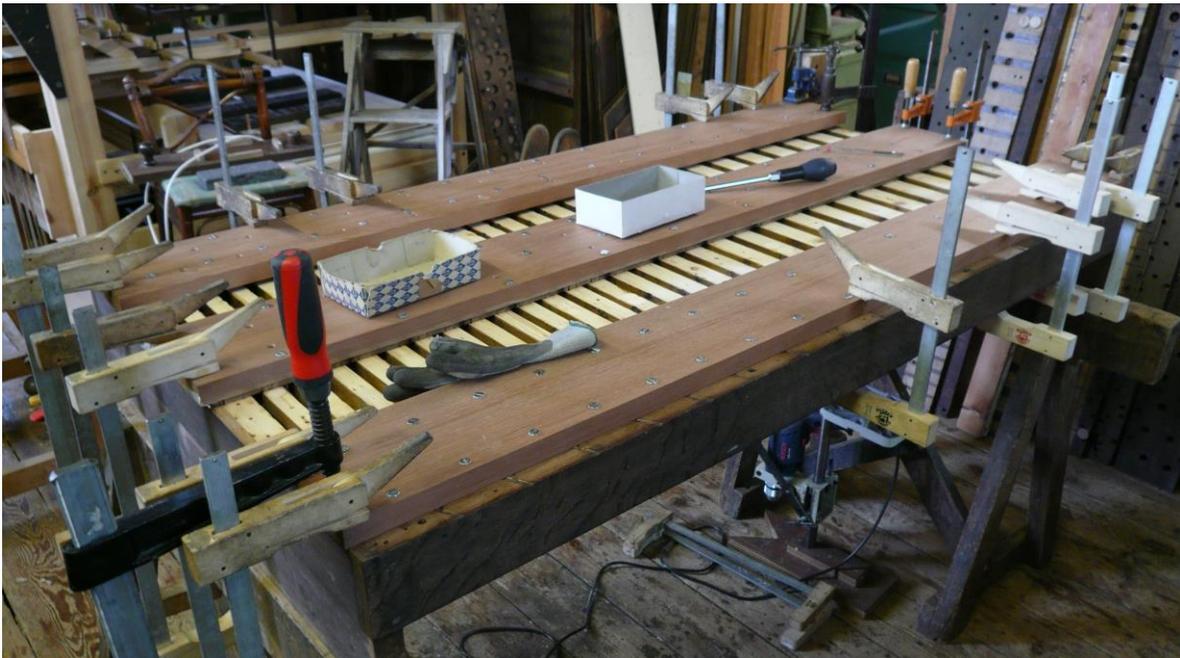
Clamping the sections of table onto the grid until the glue is dry using screwed clamping boards

The Table sections were glued back in place with a cold hide-glue (Titebond). This allowed enough time to clamp the sections securely and evenly onto the grid without the glue drying out.

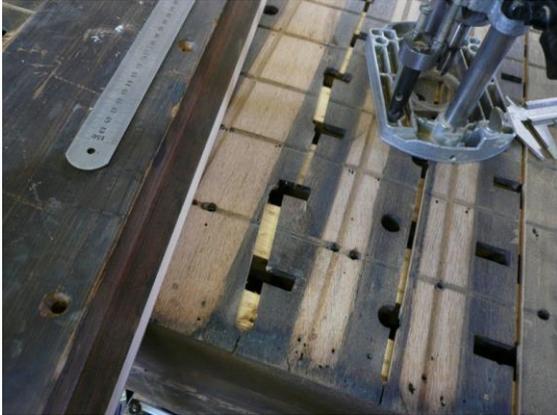
When the table sections were glued back in place, there was still evidence of shrinkage between the boards, sometimes over one millimetre.

Routing away the splits and joints in the table

The gaps were routed out to about a millimetre into the top of the bars with the smallest possible size router bit. Well-fitting pieces of seasoned oak were glued in thus restoring the table into a continuous wide plank covering the whole of the grid. In numerous places there were also still splits showing up in the table. They

were also routed out and filled with the appropriate material. This was all in all a very time consuming business.

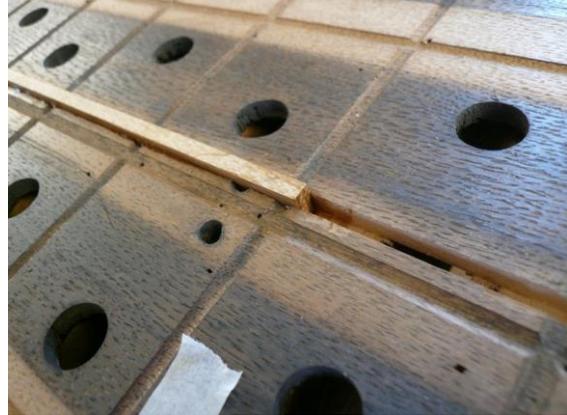
The routed out slots are filled in with seasoned oak

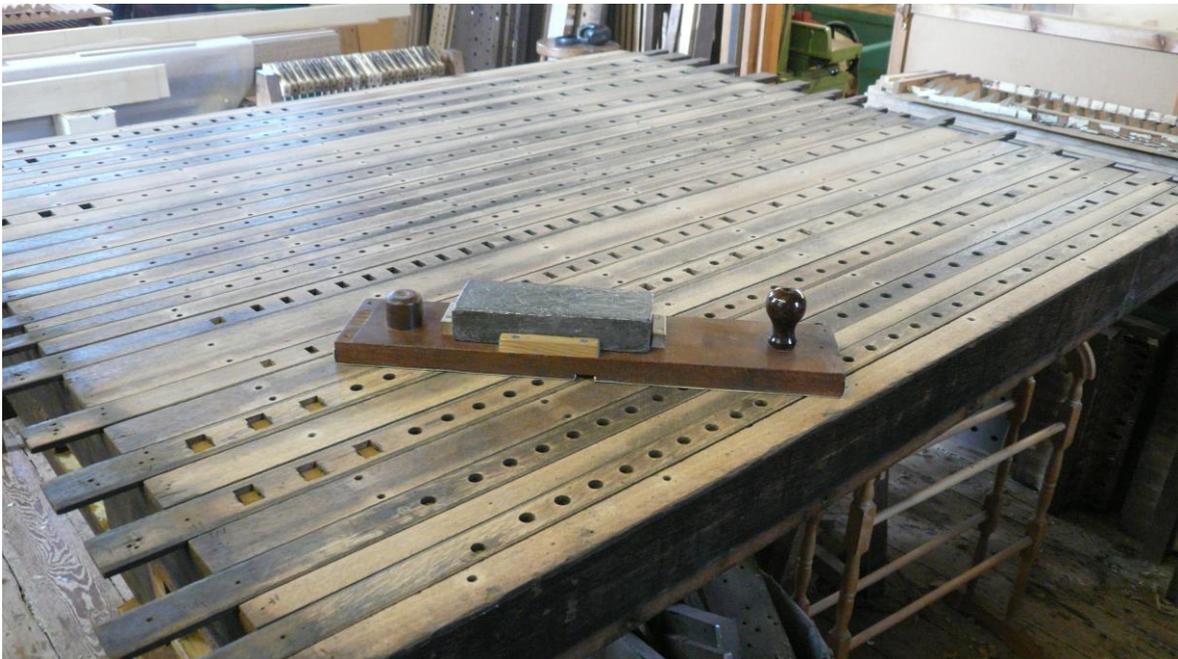
The process of flattening sliders and bearers of the Bass Great soundboard with a weighted sanding block

After the restoration of the integrity of the table a preliminary flattening took place to remove the pieces of oak standing proud of the table. The soundboard was then turned up-side-down and liberally painted out with hot glue and left to dry. The soundboard was turned over again and the table was flattened to a fine tolerance. After this the bearers were nailed back on using the salvaged old nails and some new ones. The restored sliders were pinned on and the whole surface was again flattened to a fine tolerance. After this process both sliders and bearers are of equal thickness.

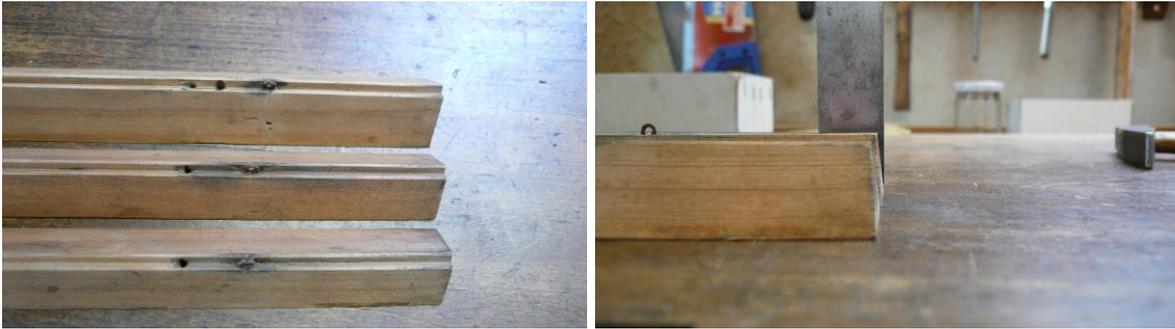
The Pallets of the Choir are the same pattern as on the Great, i.e. with an angled front. One has to come to the conclusion that these pallets most likely date from when the Great pallet slots were widened (we don't know when). All the Choir pallets were shortened by 10mm at some stage in history. Some from the tail end some from the front. This caused the need for a correction of the position of the pull-down point and the spring hole. This had been done incorrectly causing the pulldown wires to go under an angle through the bottomboard causing unwanted friction. It was decided to correct these faults and to reuse the existing Choir pallets.

Two pallets unchanged, top one shortened at front (note the forward position of the pulldown and the corrected spring hole)

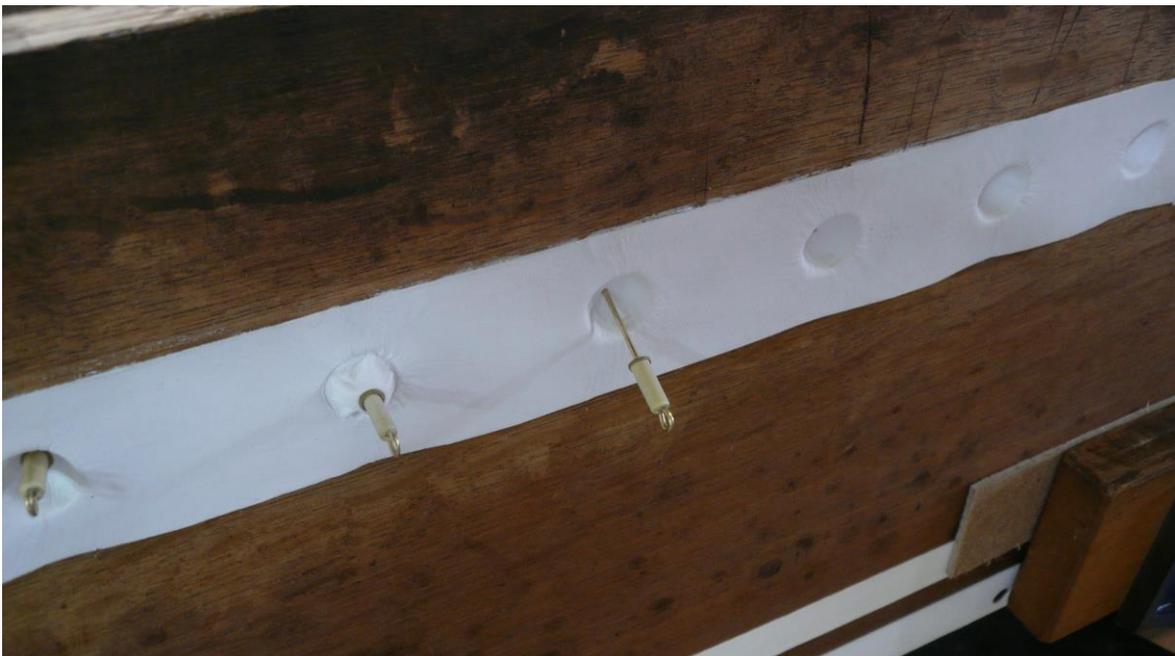
The new pulldowns inserted through the newly formed leather purses

The Brass strips were removed in favour of the reinstatement of leather purses using the surviving burned pockets in the top of the bottomboard. The details were copied from the surviving leather purses in the Choir soundboard from the 1764 George England organ in Gravesend.

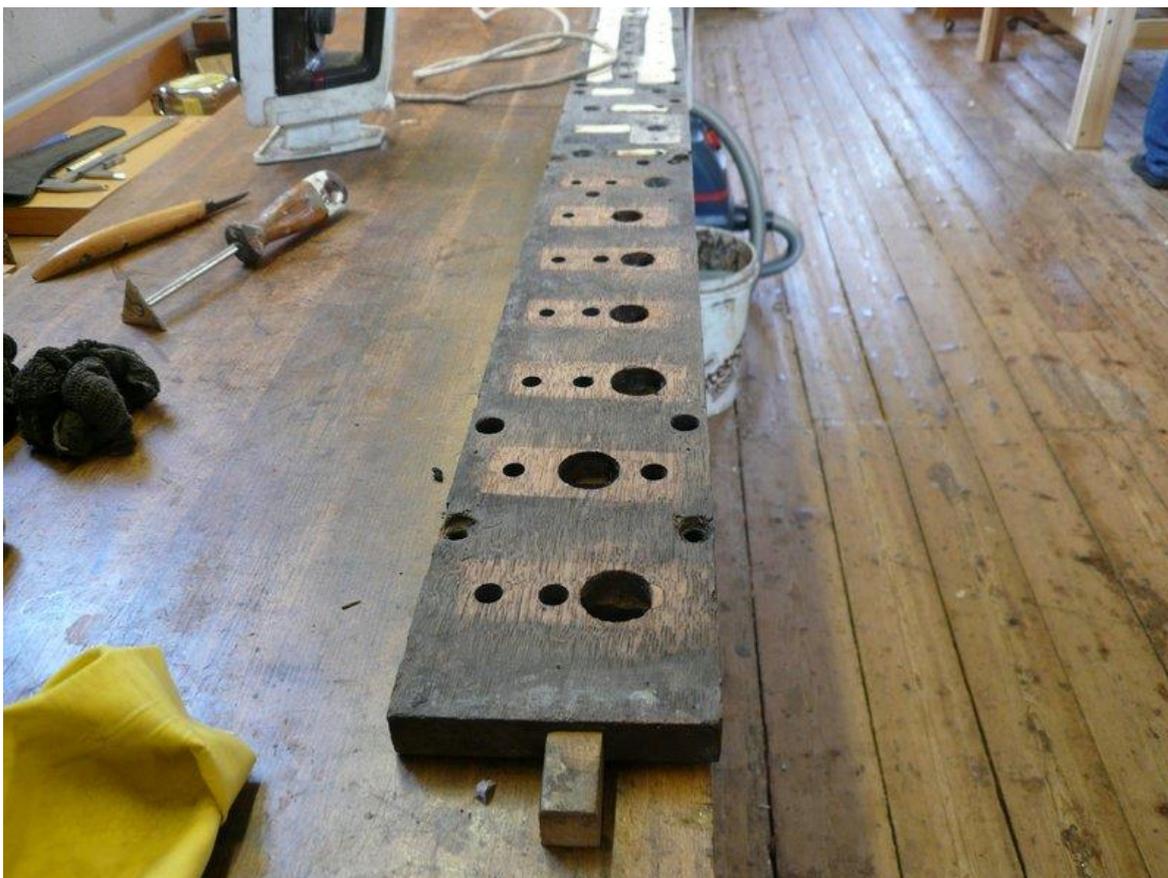
Several stop changes were evident while looking at the upperboards. Some had been given veneers to take pipe tips of a new stop in a different place to where the original pipes had stood. The Mixture upperboard had in the treble been reduced to single rank, while in the bass large conveyance holes were feeding off-notes. (the Mixture was replaced by JC Bishop with a Dulciana which must have been conveyanced into the bass of the stop Diapason)

Conveyance holes in the Choir Mixture upperboard and leathered-over treble holes

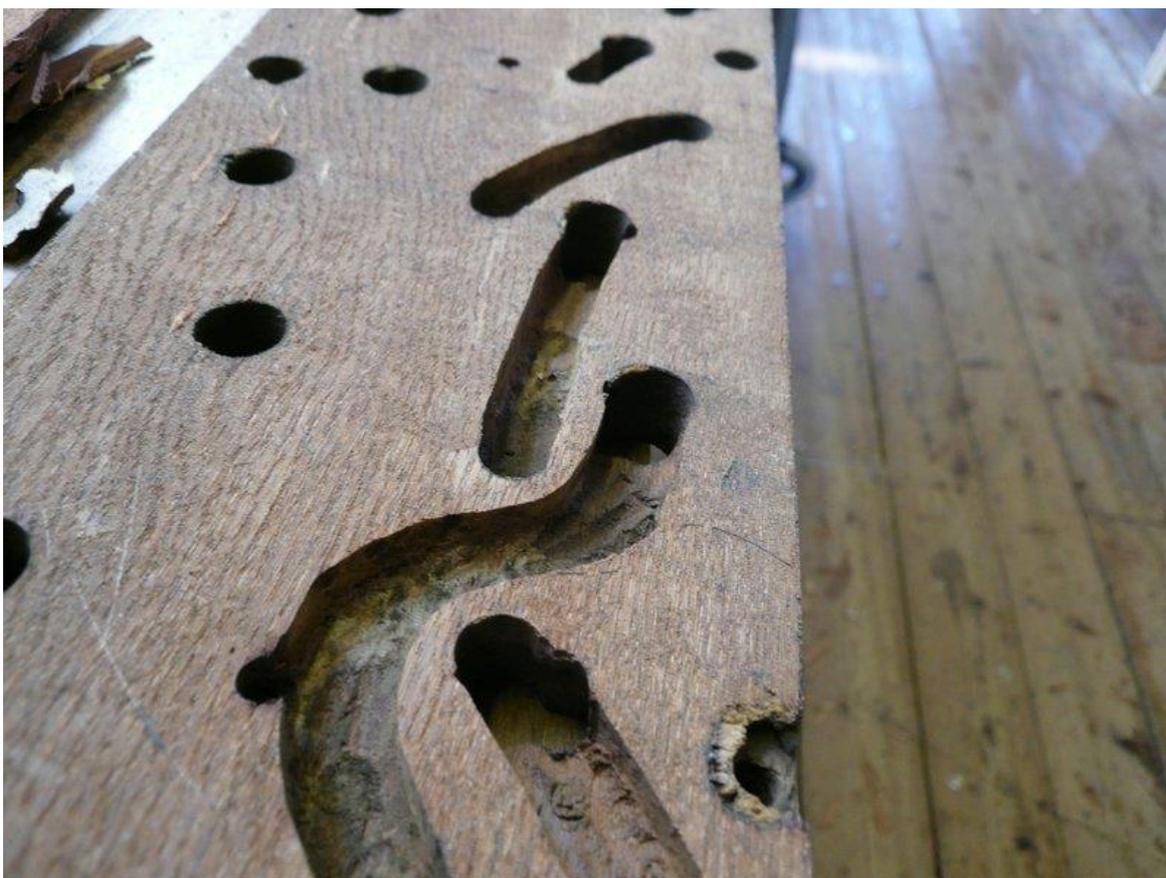
The second upperboard from the front had a veneer glued on it to take the old Back Open from the Great from CC upwards (alteration by Gray & Davison 1851) on slider number 4. Although this slider and the upperboard holes above are no different from the three other reed sliders, it is believed that this is the only slider on the soundboard which could have originally accommodated the Quintadena, called Flute or Flute cfaut in later accounts of the organ (was this a revoiced Quintadena?). To judge by the holes in the slider below CC the compass of this stop is unlikely to have extended below  $c^{\circ}$ . Although accounts of the organ give the number of pipes for a Flute Cfaut (formerly Quintadena) to be 56, suggesting that the stop on this slider was full compass, the holes below CC are much smaller than the equivalent holes in the 4' Flute on the same soundboard. This suggests that the slider holes below  $c^{\circ}$  down to CC were most likely enlarged in 1851 by Gray & Davison to accommodate the old Back Open Diapason from the Great down to CC.

The second upperboard from the front with the veneer removed showing grooving (alteration?).

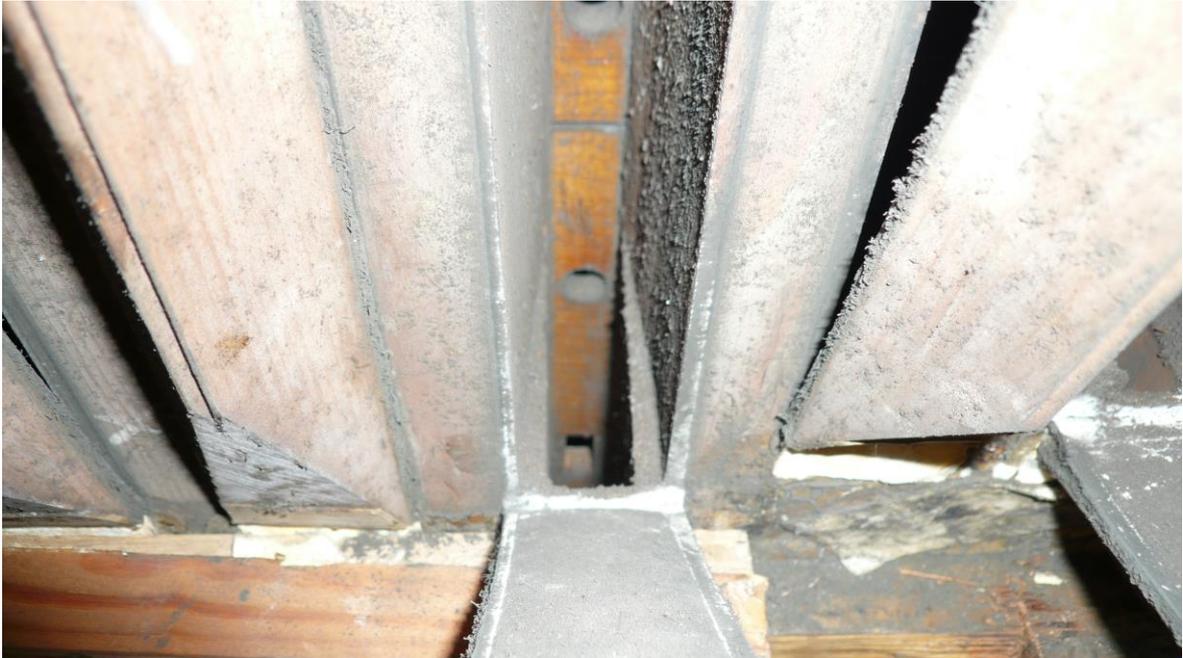
During the dismantling and cleaning of the bottom of the grid, evidence was uncovered that all the pallet slots have at some stage been significantly widened by cutting away the sides of the bars. New wider pallets therefore replace the original ones.

A look into a widened groove. Note the original groove width behind the tail of the pallet.

The widening of these pallet slots can only have resulted in a much heavier touch without the benefit of extra capacity, as the original pallet slot capacity is already larger than that of the groove.

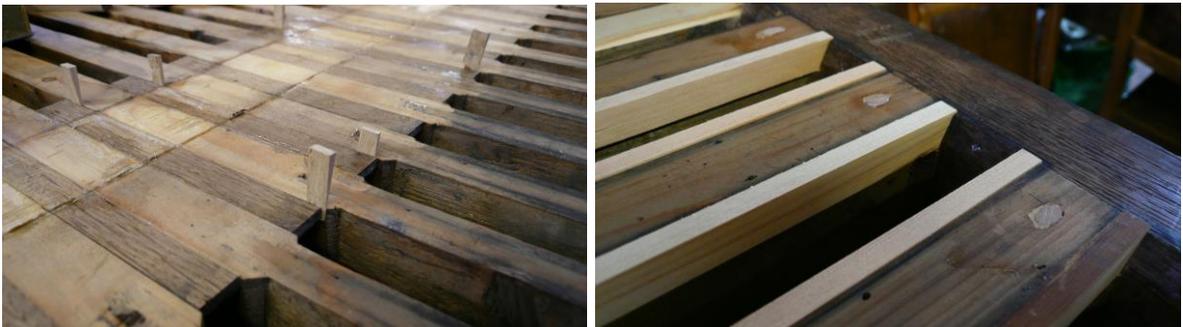
Prior to tackling the pallet slots the grid had to be stabilised Recycled old pine is let into the edge of the grooves

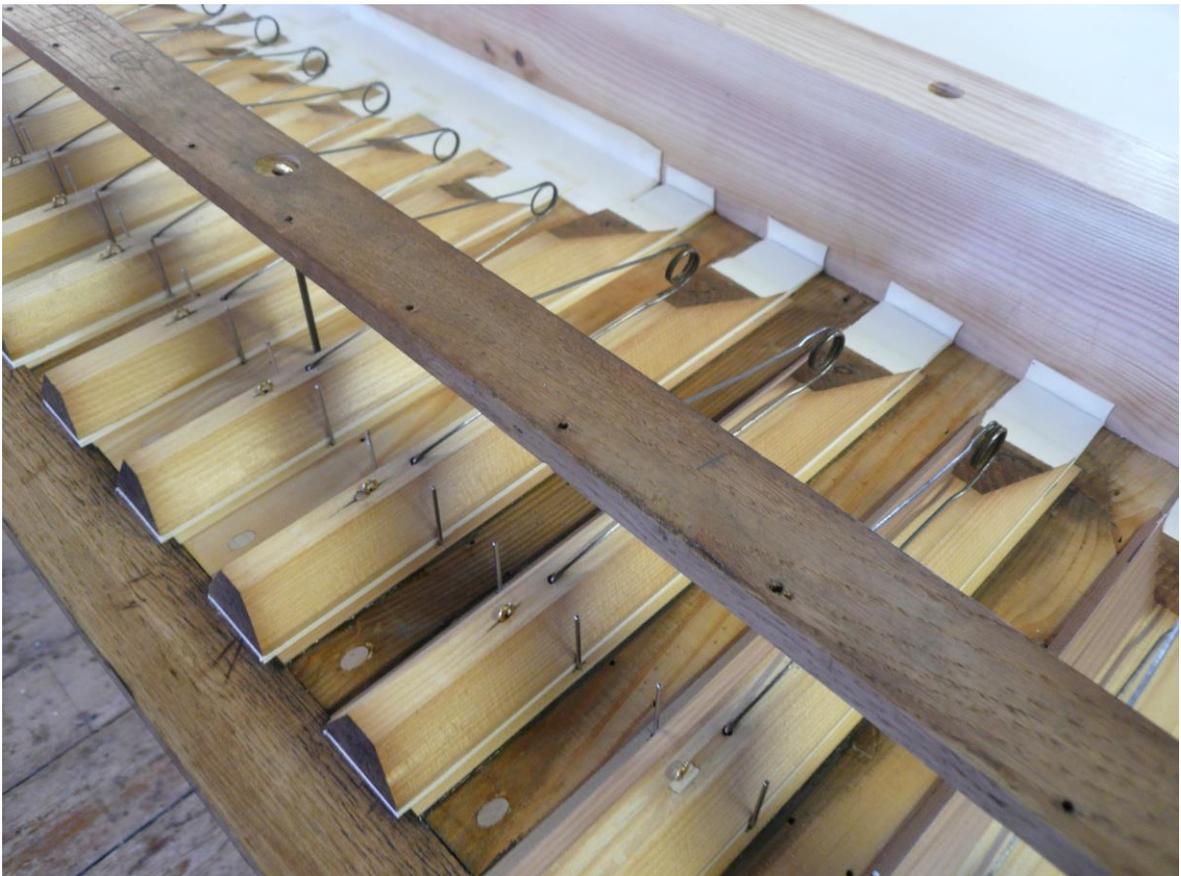
The great pallet box restored (note the widened pallet slots filled in to their original width and the pallets adapted to suit)

The pallet slot widths have therefore been restored over a height of 20mm of the groove height. This allowed sufficient depth for the fixing of the guide pins.

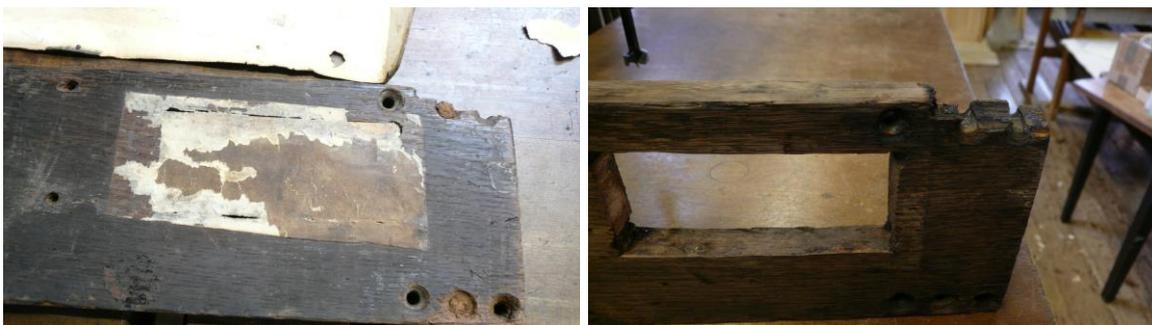
- 1 With oblong hole of 134x60mm with a wind trunk nailed against it (quite likely the original Swell feed as there is no evidence of any other way to get wind to the Swell).
- 2 With a wind trunk fitted by means of a screwed flange (3 screws) to feed the Swell or the pedal pipes ( CCC – DDD<sup>#</sup>) added by Lincoln?
- 3 The hole is blocked off and leathered over. (Gray & Davison made a new Swell with its own new wind supply and separated the pedal wind from the manuals.)

Trunk hole in Bass soundboard faceboard blocked up and opened up (note the moved positions for screws)

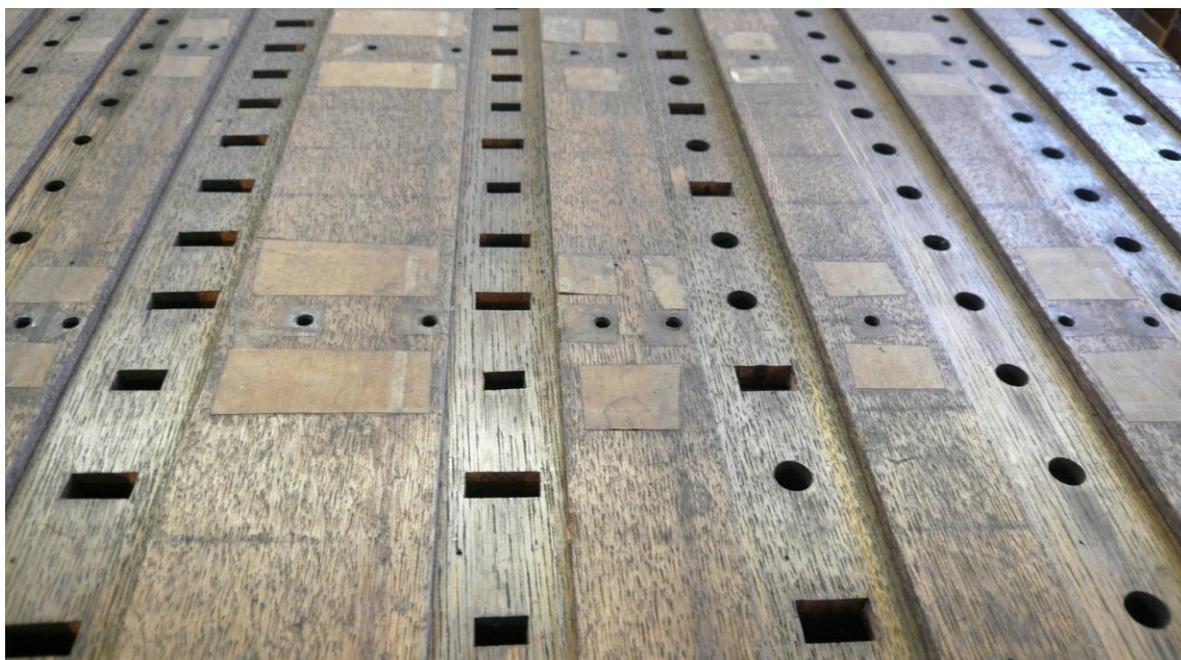
The enlarging of the round holes in the soundboard (through burning) may have been done by Gray & Davison in 1851.

Enlarged holes of the Sesquialtra, Furniture and Front Trumpet (slider 4, 5 and 6 from the right)

Extra holes made to enable the compass to be extended from d''' to f''' were filled in. Enlarged holes were left as they are, when this didn't pose a change in their original function.

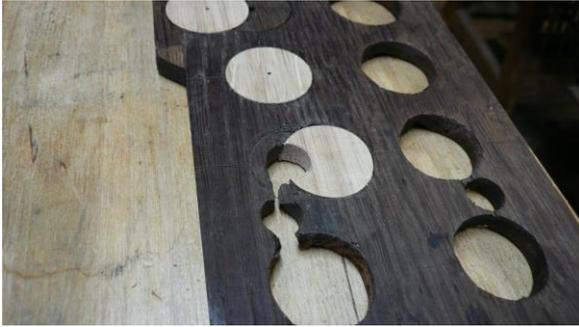
One half of an original rackboard hole in the middle range of the Tierce had survived, probably due to its close proximity to a rackpillar. The size of this hole suggested strongly that the original Tierce would have been of the same scale as the surviving Twelfth.

Tierce and Larigot rackboard (note the half surviving hole)

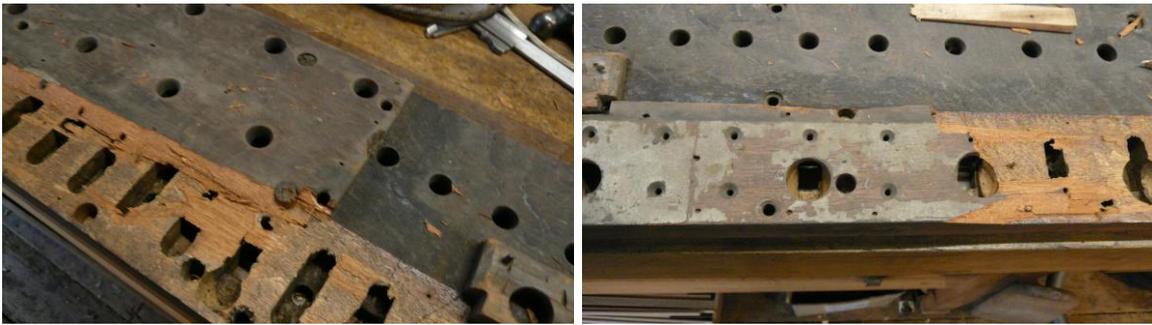
The upperboard for the two Trumpets had possibly been altered the most by Gray & Davison.

One of the two Trumpets was substituted for a two rank mixture, whilst a second trumpet was replaced with a much larger scale Posaune 8'. The both required the need for significant grooving and a veneer on top of the upperboard.

The upperboard of the two Trumpets showing evidence of stop changes

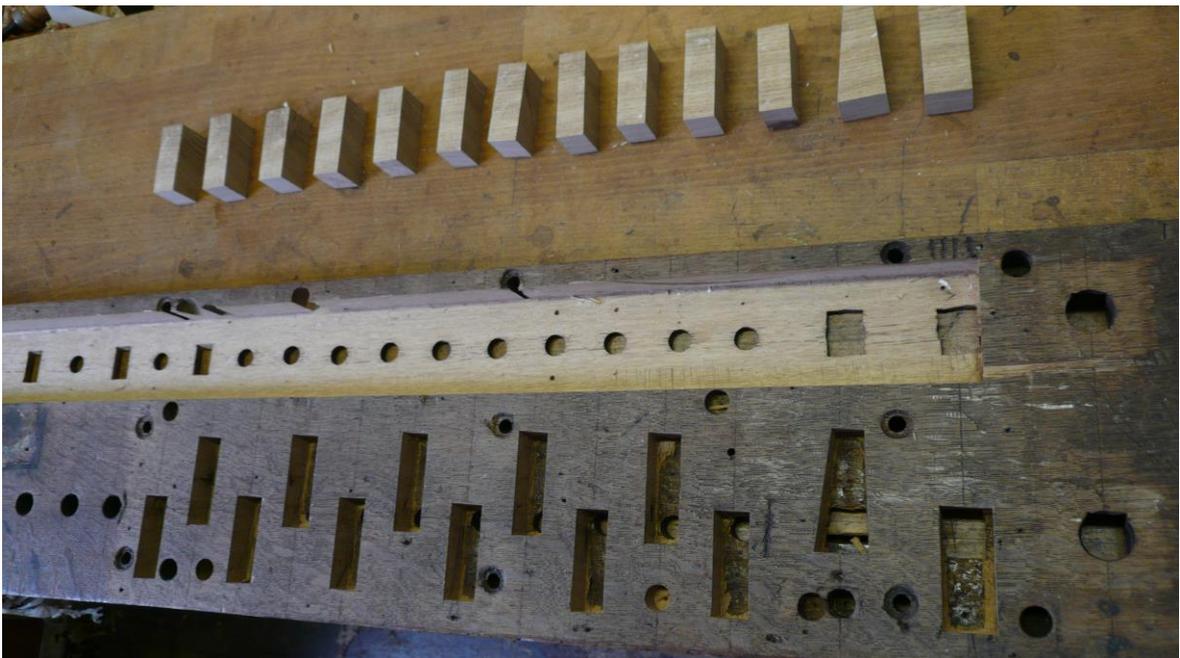
The upperboard for the trumpets being restored to its original function by piecing in non-original grooving

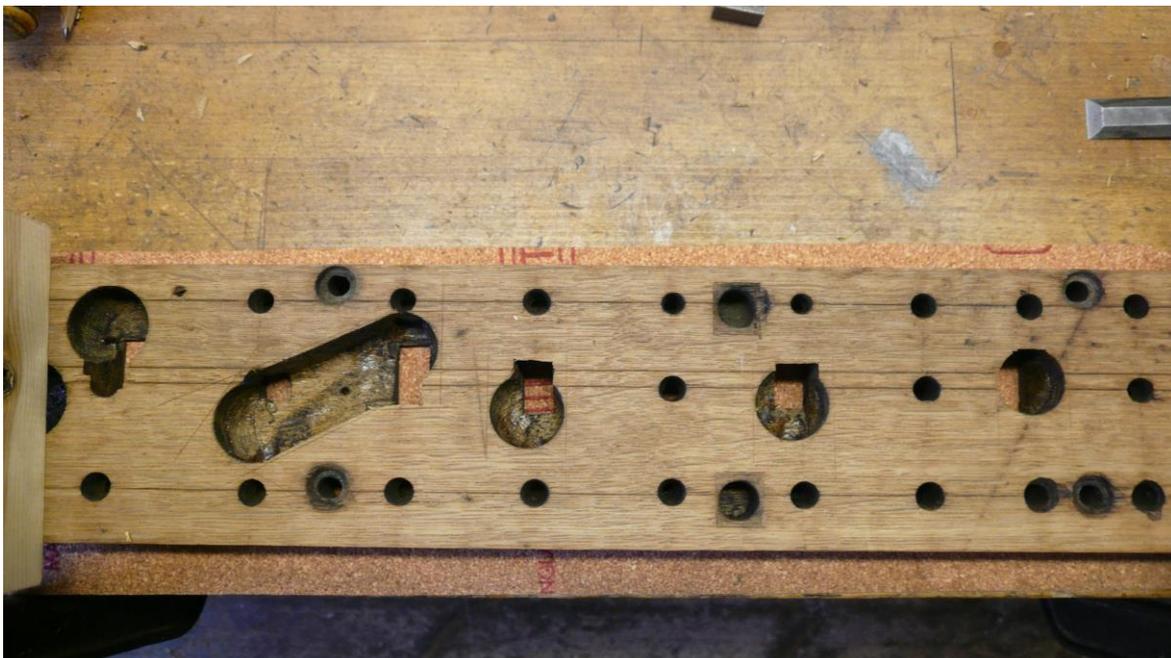
In an early 20<sup>th</sup> century rebuild the furniture and the mixture were replaced with one 16' Bourdon from G ( $10^{2/3}$ ). Each slider would supply every other note in turn. This resulted in the furniture receiving a veneer and large holes and grooves being drilled into it to take the wooden pipe feet.

Furniture upperboard with veneer removed showing grooving and wooden pipe foot holes every other note

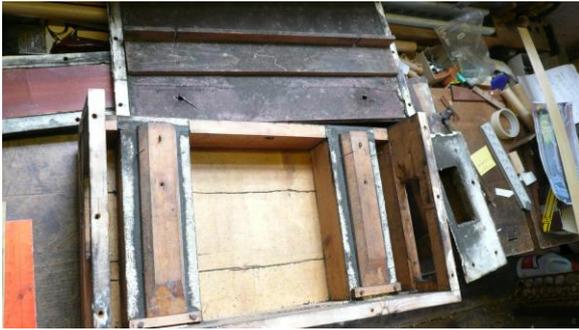
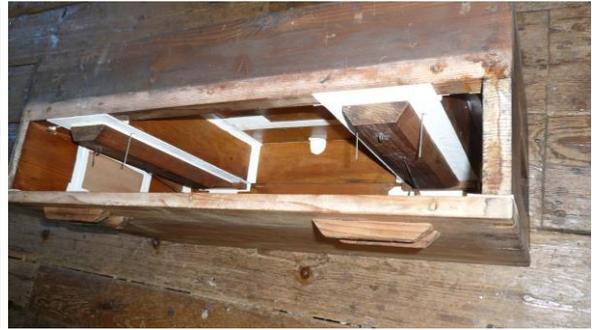
Through the significant weight, the flanges on which the pipes stood were quite often split. These flanges were strengthened and given a slider for the ease of regulating the wind flow into the pipes.

CCC and CCC# soundboard during dismantling and after restoration (note the leathered pallets close against leather)

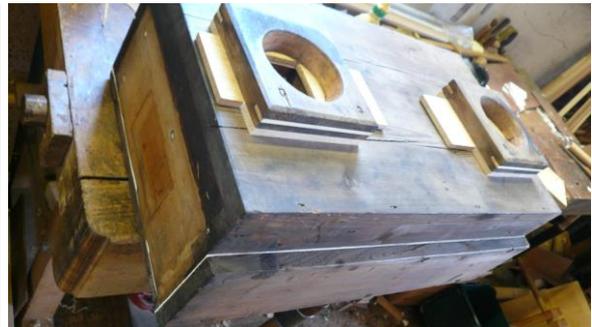
Strengthened toe-blocks with new regulation sliders
