Case study
The restoration
of the
1755 John Snetzler Organ
at
Clare College Cambridge

Case & Carving

WILLIAM DRAKE Ltd
Organ Builder
Chapel Street, Buckfastleigh, Devon TQ11 0AB

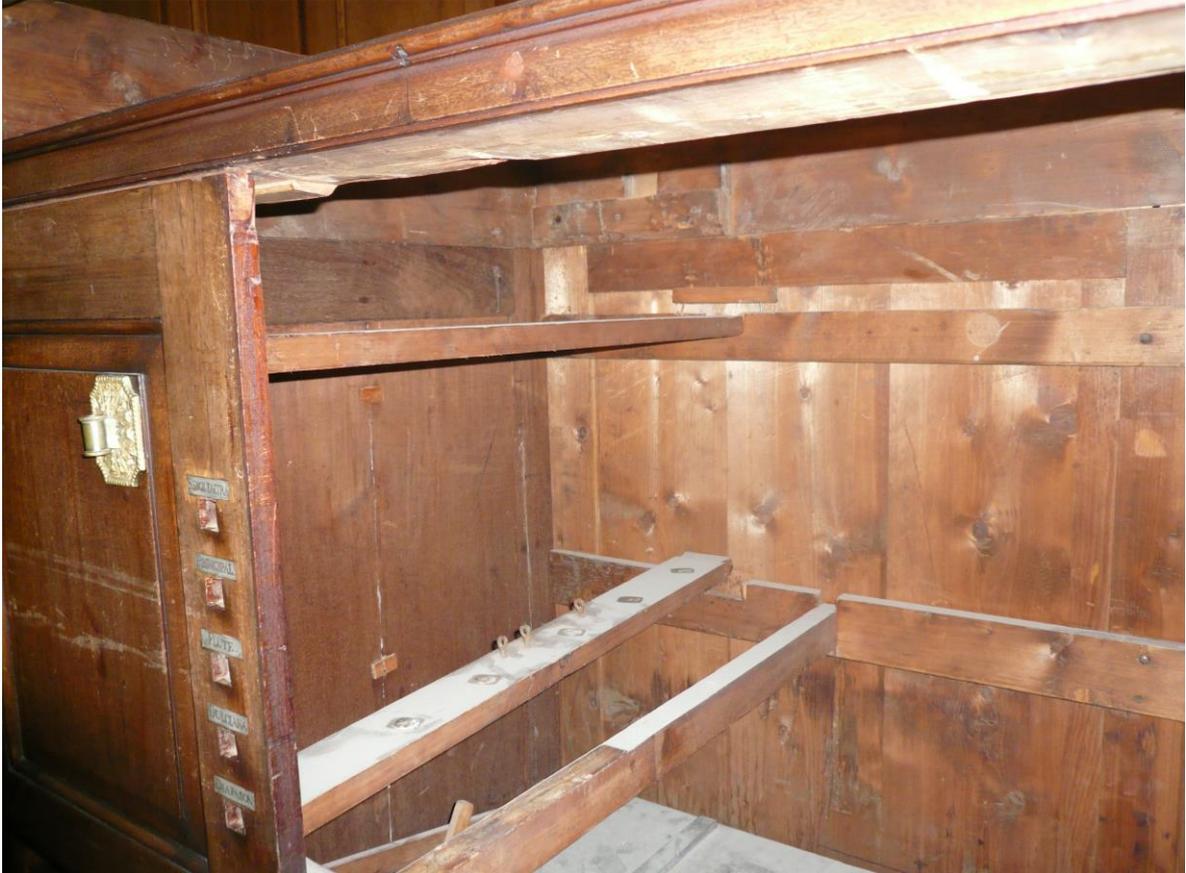
The finish of the case was in quite a shabby state and had been interfered with at least once during the lifetime of the instrument. The front uprights had endured some damage in the past, possibly because of collapse of the scalloped toe board facing which supports the middle uprights and thereby also the pipe shades. Repairs can be spotted at the top of the arched middle section where tenons have been replaced. These repairs were accepted as historic and have been left as they are during this present restoration.

Condition of the finish during dismantling

The case was completely stripped from its finish using denatured alcohol. During the restoration of the finish one could notice that the finish of the wood surfaces was rather rough, as if finished with a scraper rather than with a plane.

The refinishing was done with oils, earth pigments and a modicum of filling of the pores in the mahogany. The built-up finish was completed with a wax finish.

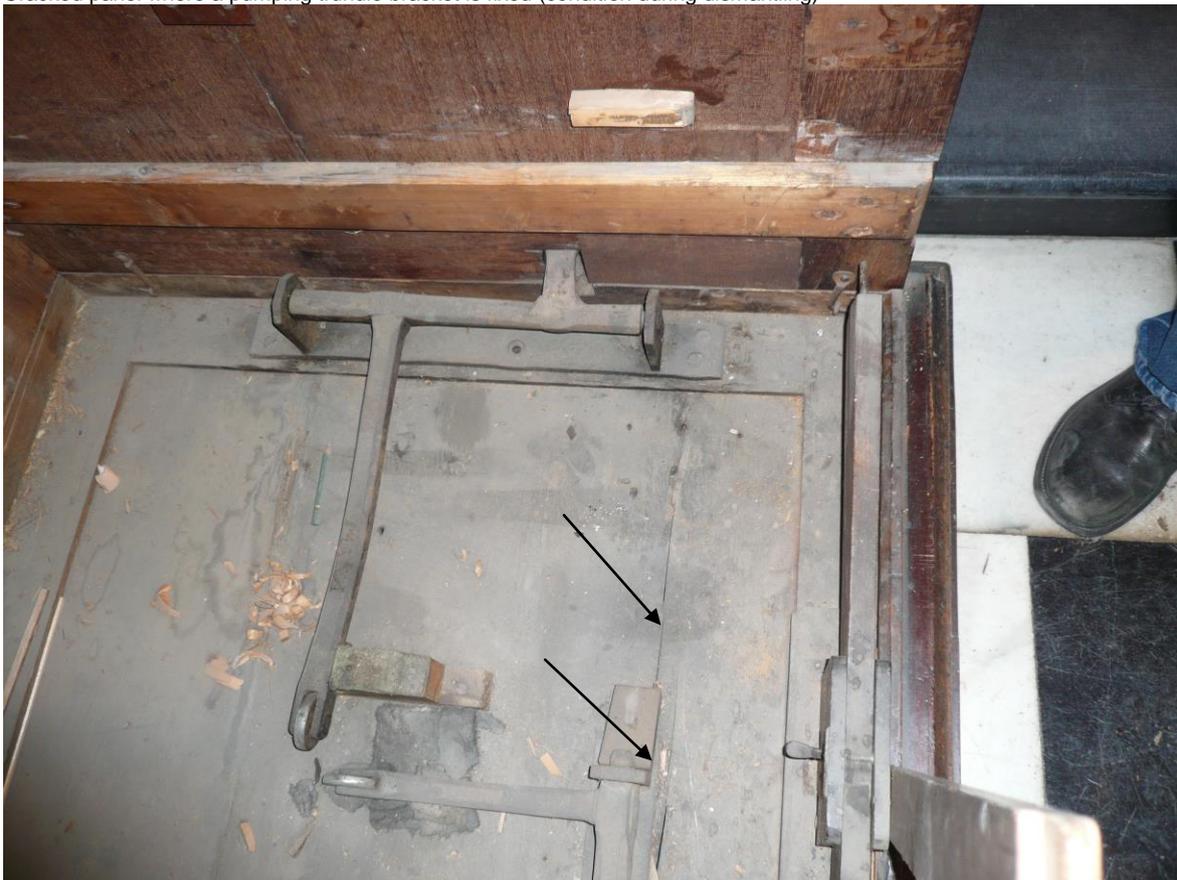
The pumping mechanism is fixed to a rather insignificant structure of frame and panel which forms the floor of the organ. This was in an unstable condition and was thereby reinforced from below.

Cracked panel where a pumping trundle bracket is fixed (condition during dismantling)

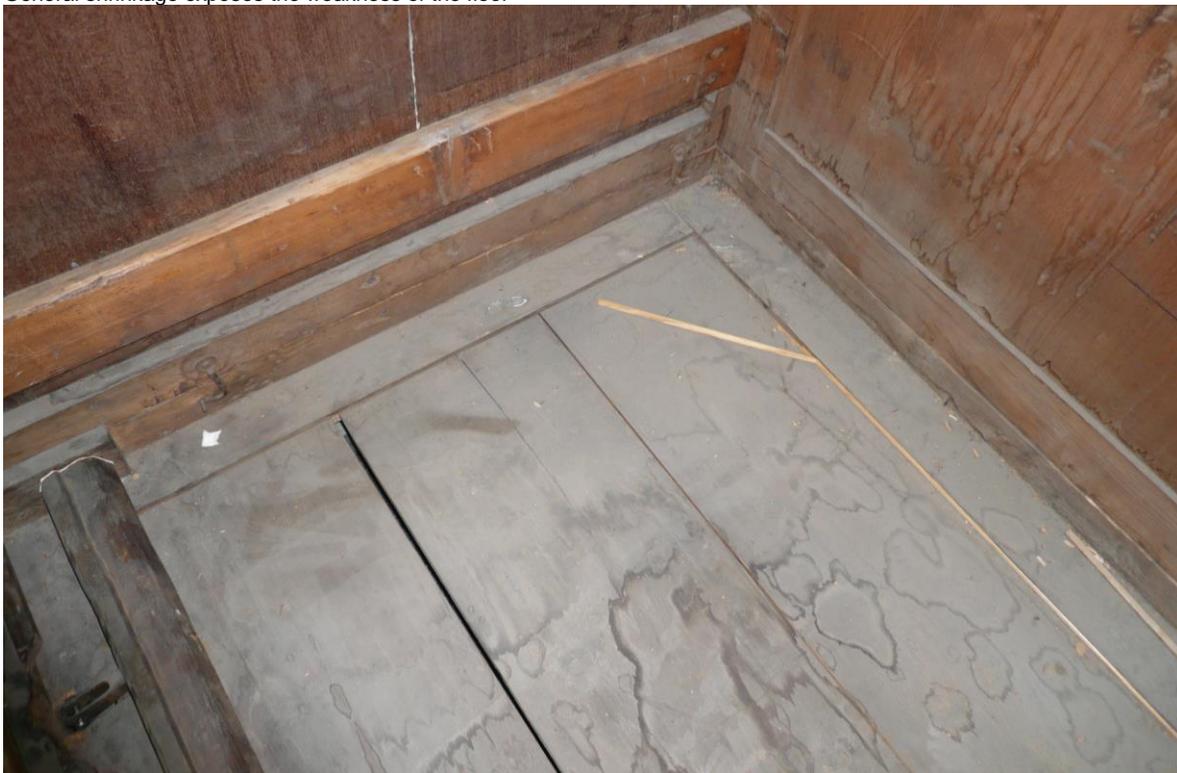
General shrinkage exposes the weakness of the floor

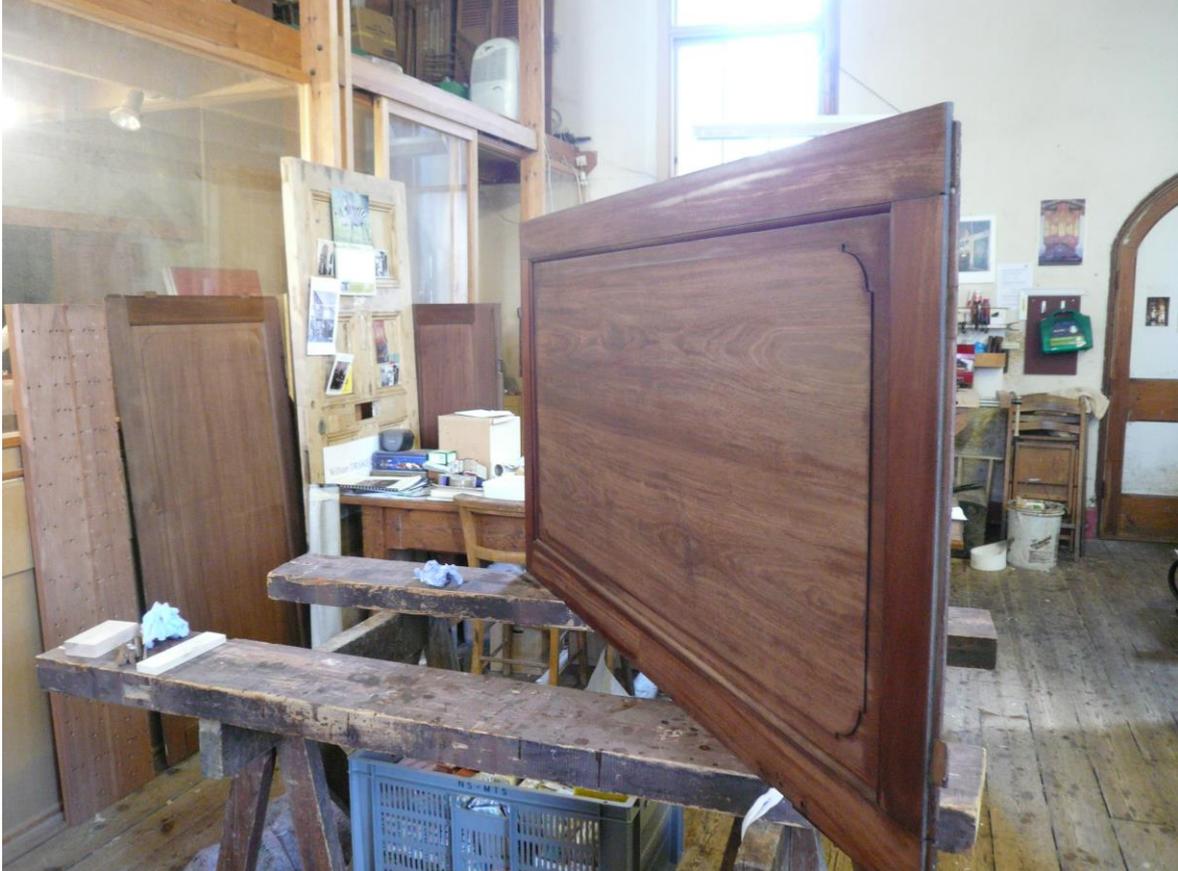
The side panels stripped back to the wood showing the beautiful corners to the fielded panels

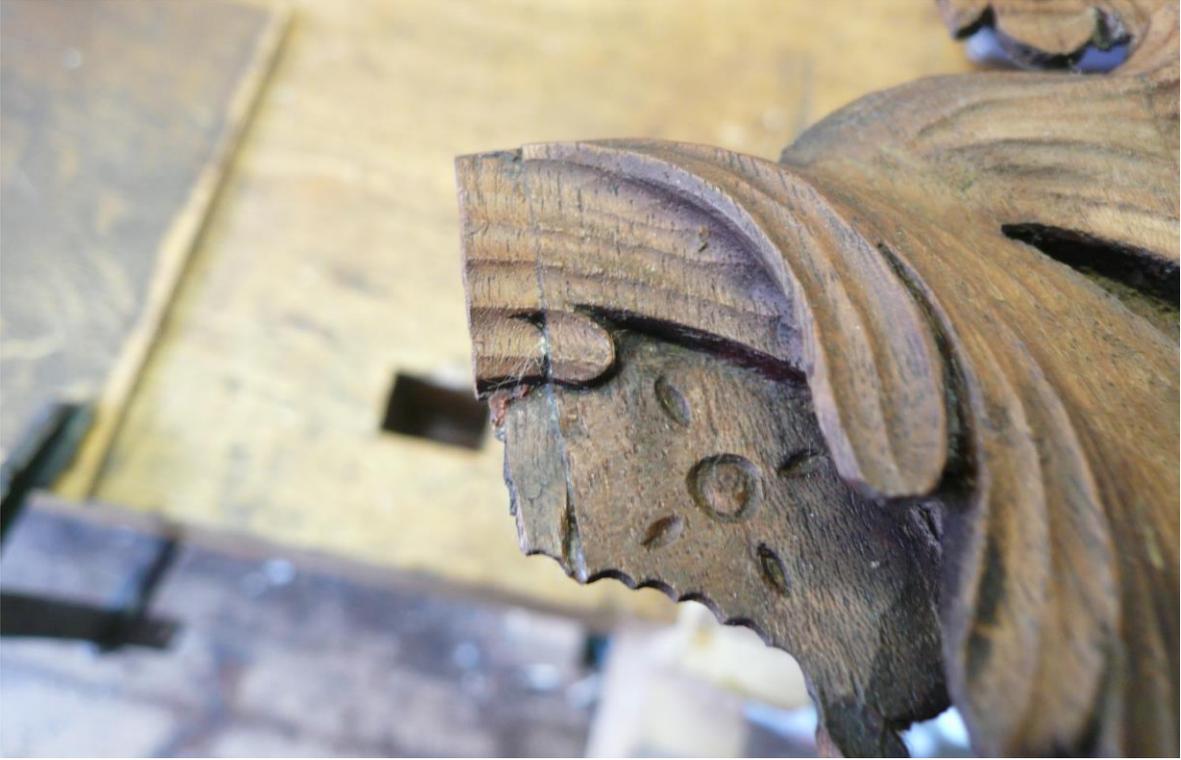
The carved pipe shades were in a bad condition. Old bad repairs had been done with inappropriate glues and were very difficult to get apart again. Sometimes where bits were missing in the past, new bits of carving weren't quite right and the old carved surfaces were compromised to fit the bad matching new bits.

An original fragment with a new piece inappropriately carved (the old piece also re-shaped) and fitted with modern glue

All finish and all non-original bits of wood were removed from the pipe shades, and historic repairs repeated once again. The central pipe shade had a substantial piece of new carving (almost a quarter) which was found to be of inferior quality and not to match the old work. This also was removed and replaced with a newly carved piece.

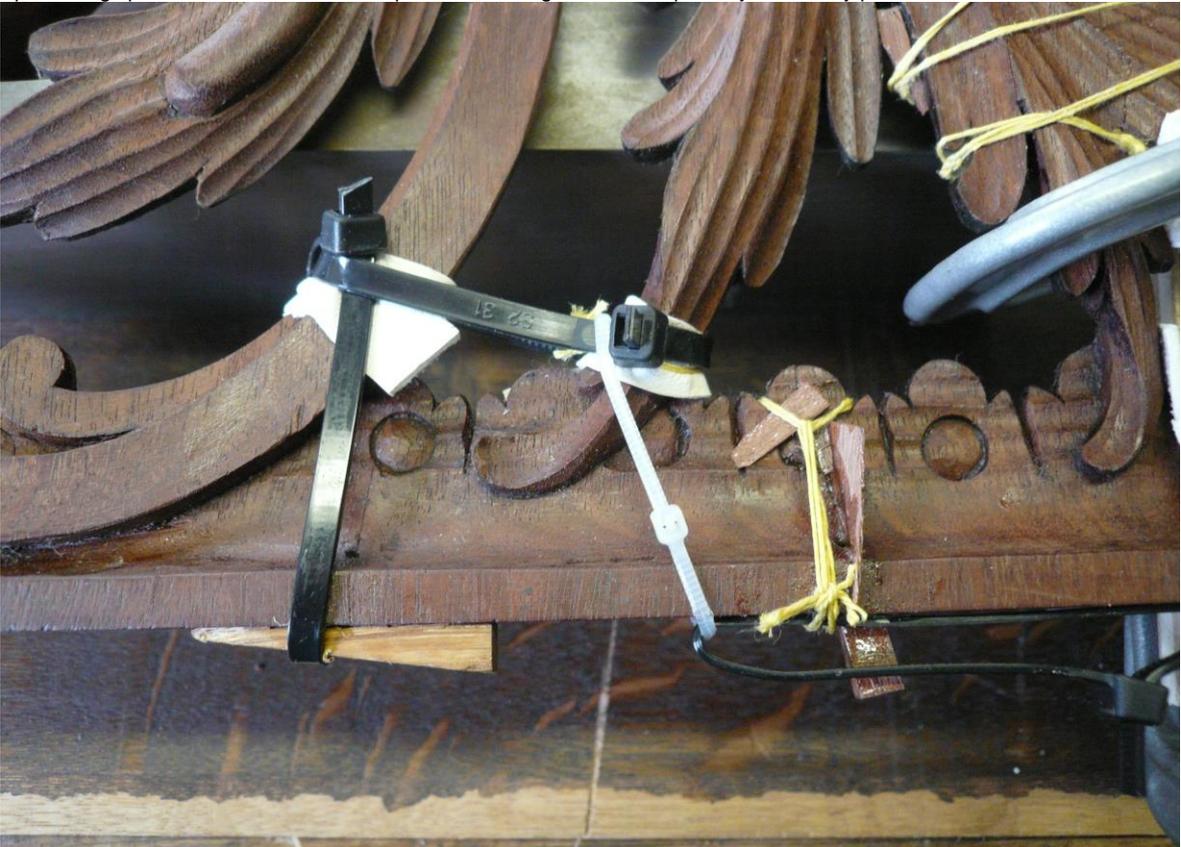
Splits being spliced in with veneer and repaired with hot glue and clamped any which way possible

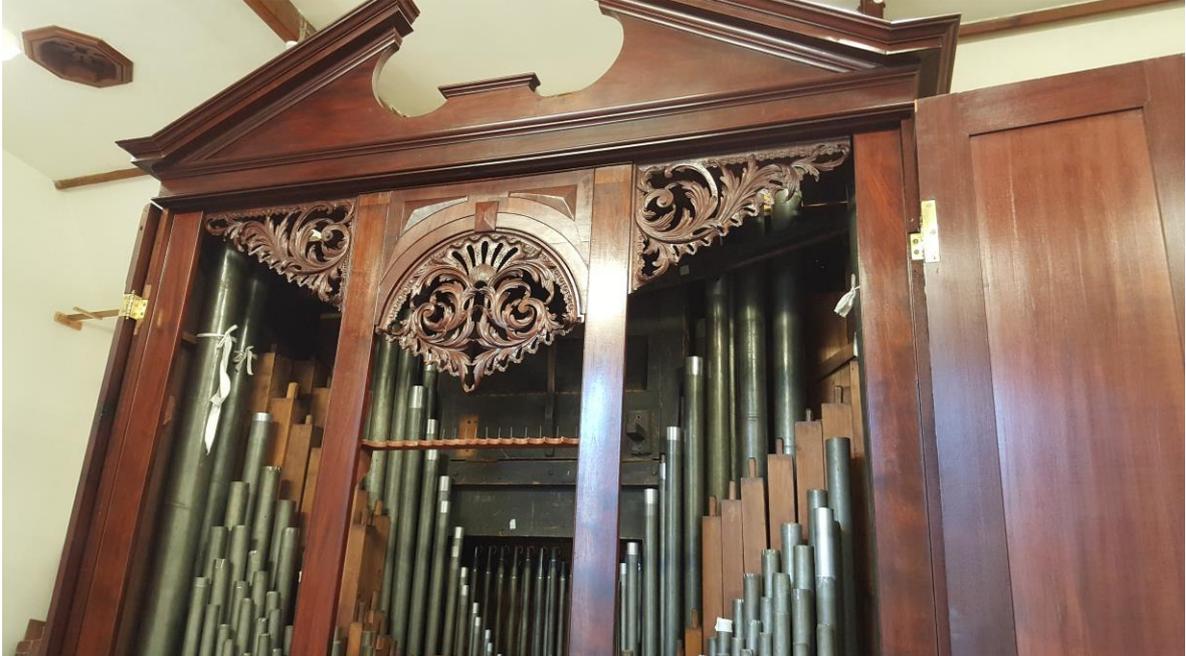
Restored casework still shows the repaired extended uprights. Note the exquisitely restored carvings

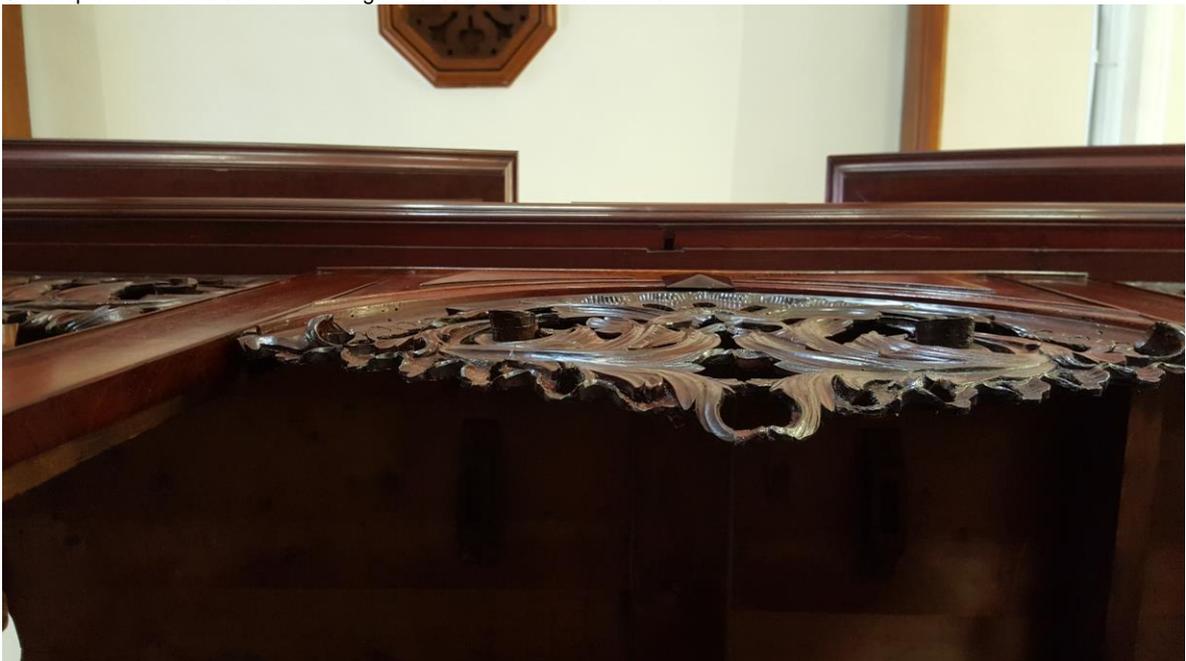
Close-up of the middle section showing the excellent movement in the form
