Case study  
The restoration  
of the  
1755 John Snetzler Organ  
at  
Clare College Cambridge

Case & Carving

**WILLIAM DRAKE Ltd**  
Organ Builder  
Chapel Street, Buckfastleigh, Devon TQ11 0AB

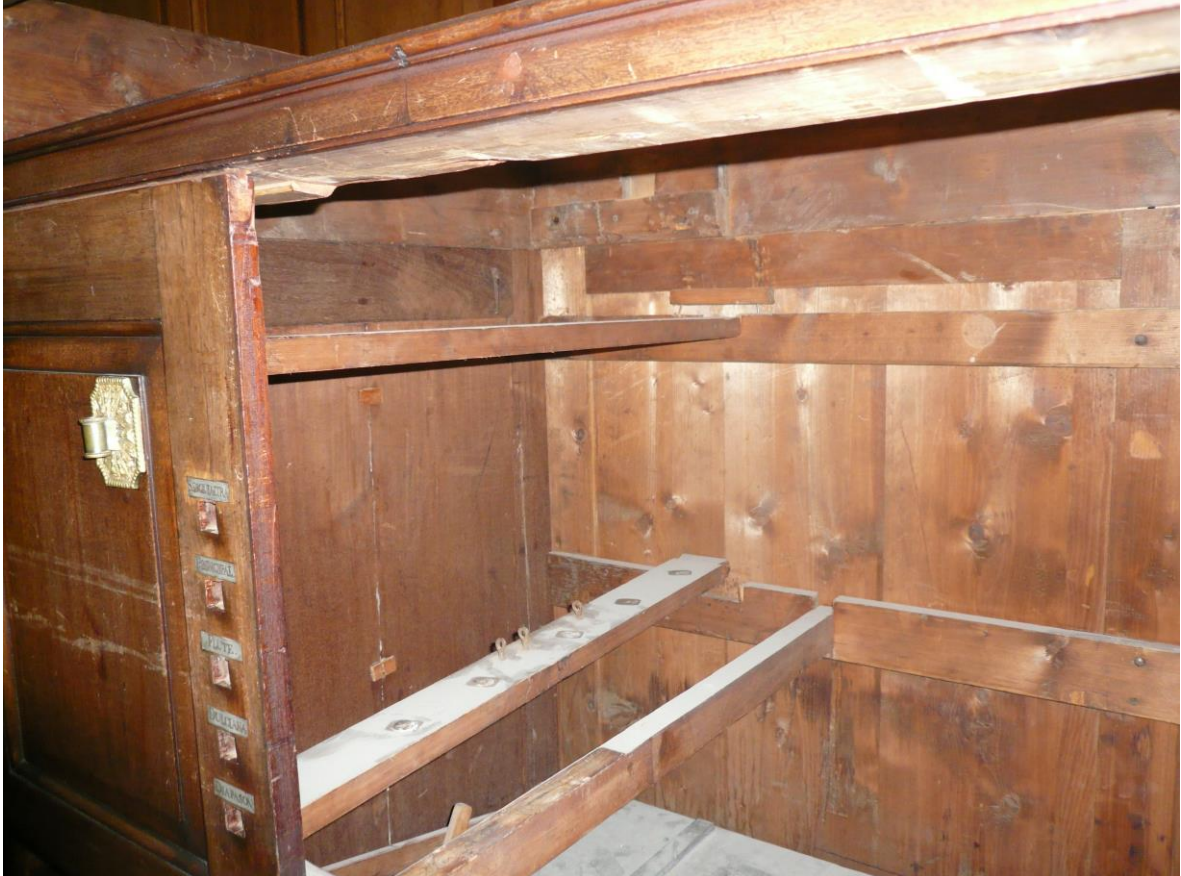
The finish of the case was in quite a shabby state and had been interfered with at least once during the lifetime of the instrument. The front uprights had endured some damage in the past, possibly because of collapse of the scalloped toe board facing which supports the middle uprights and thereby also the pipe shades. Repairs can be spotted at the top of the arched middle section where tenons have been replaced. These repairs were accepted as historic and have been left as they are during this present restoration.

Condition of the finish during dismantling

The case was completely stripped from its finish using denatured alcohol. During the restoration of the finish one could notice that the finish of the wood surfaces was rather rough, as if finished with a scraper rather than with a plane.

The refinishing was done with oils, earth pigments and a modicum of filling of the pores in the mahogany. The built-up finish was completed with a wax finish.

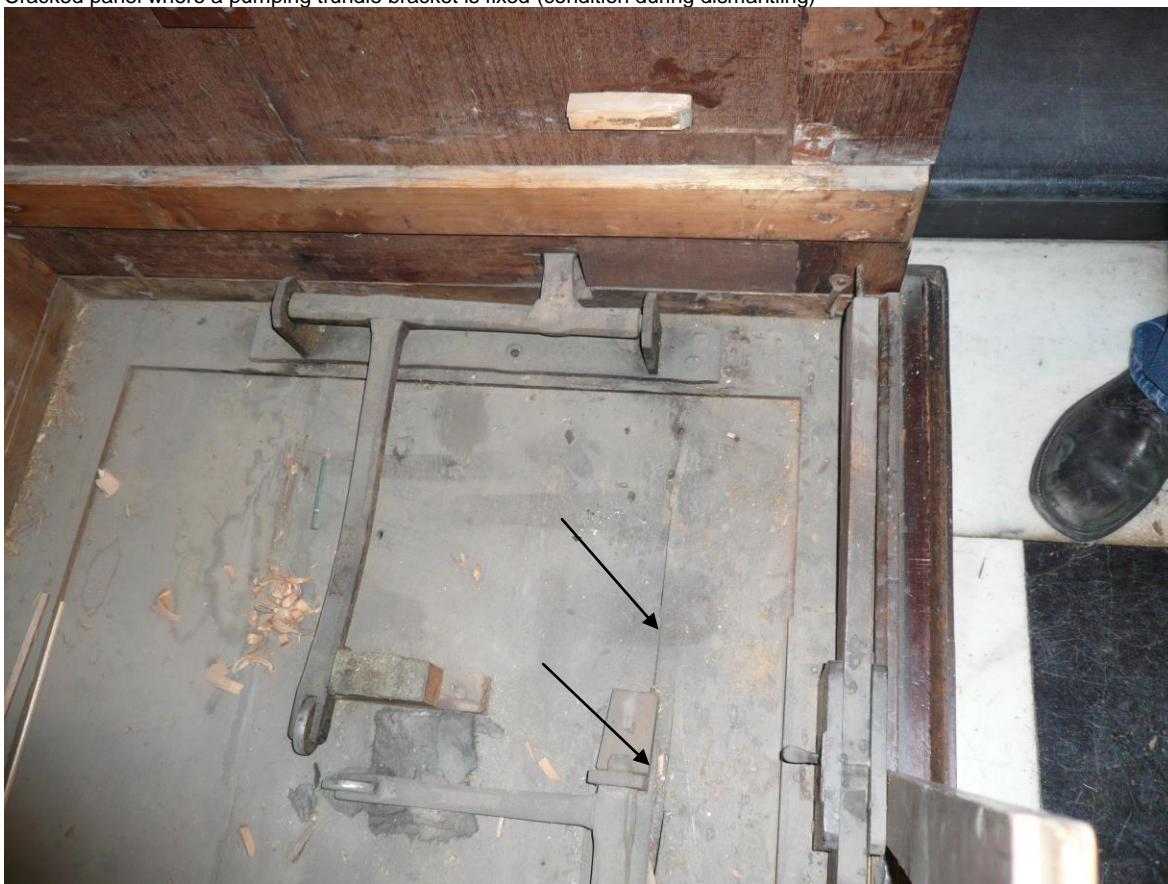
Cracked panel where a pumping trundle bracket is fixed (condition during dismantling)

The pumping mechanism is fixed to a rather insignificant structure of frame and panel which forms the floor of the organ. This was in an unstable condition and was thereby reinforced from below.

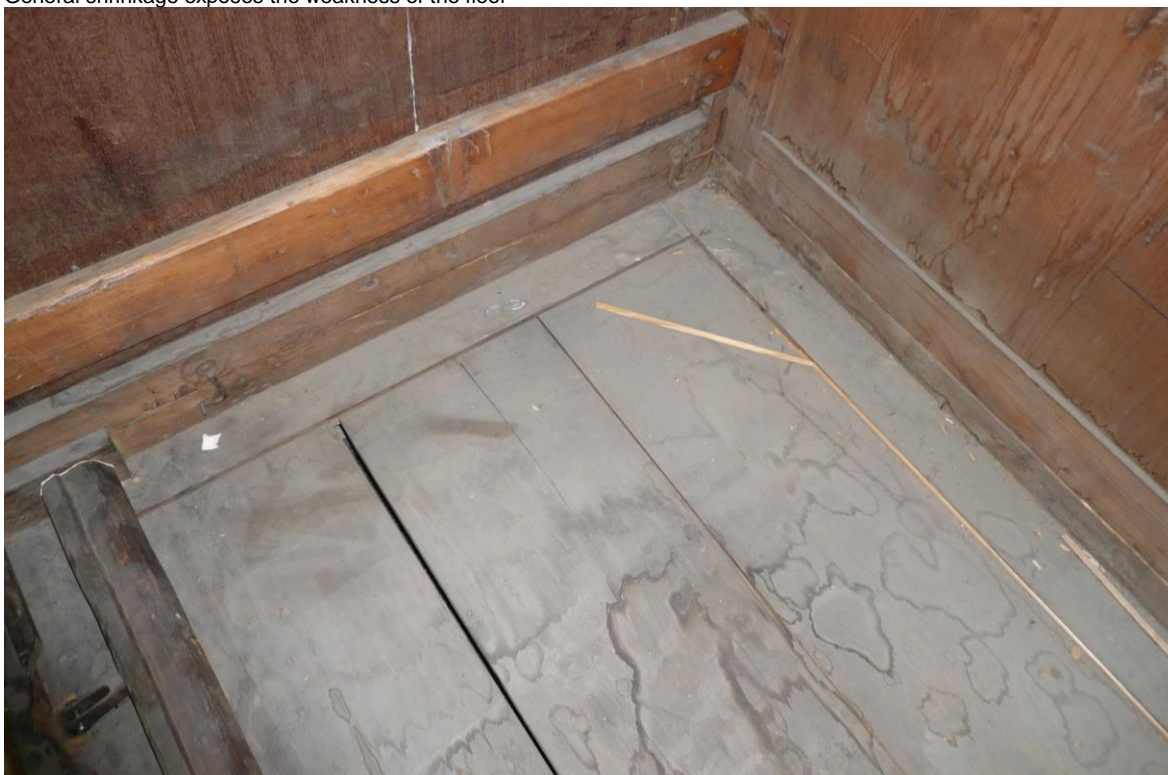
General shrinkage exposes the weakness of the floor

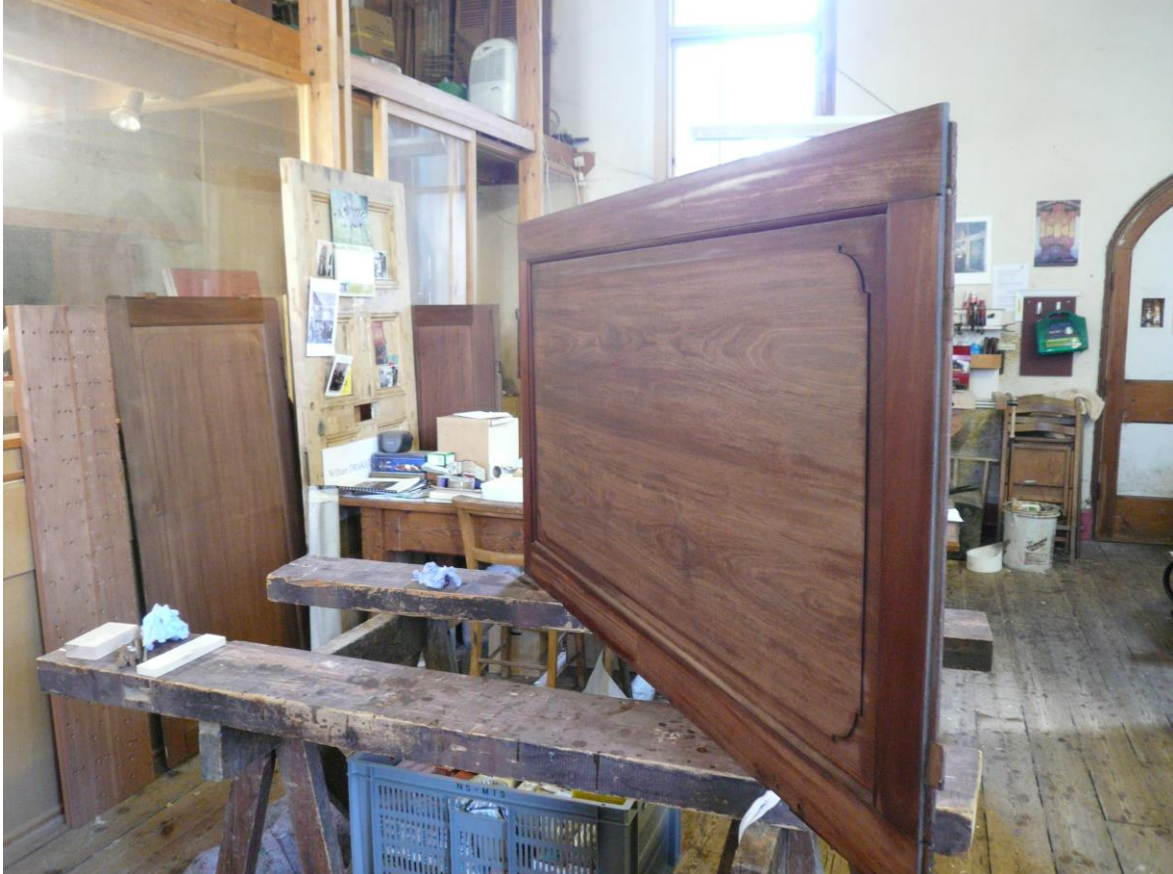
The side panels stripped back to the wood showing the beautiful corners to the fielded panels

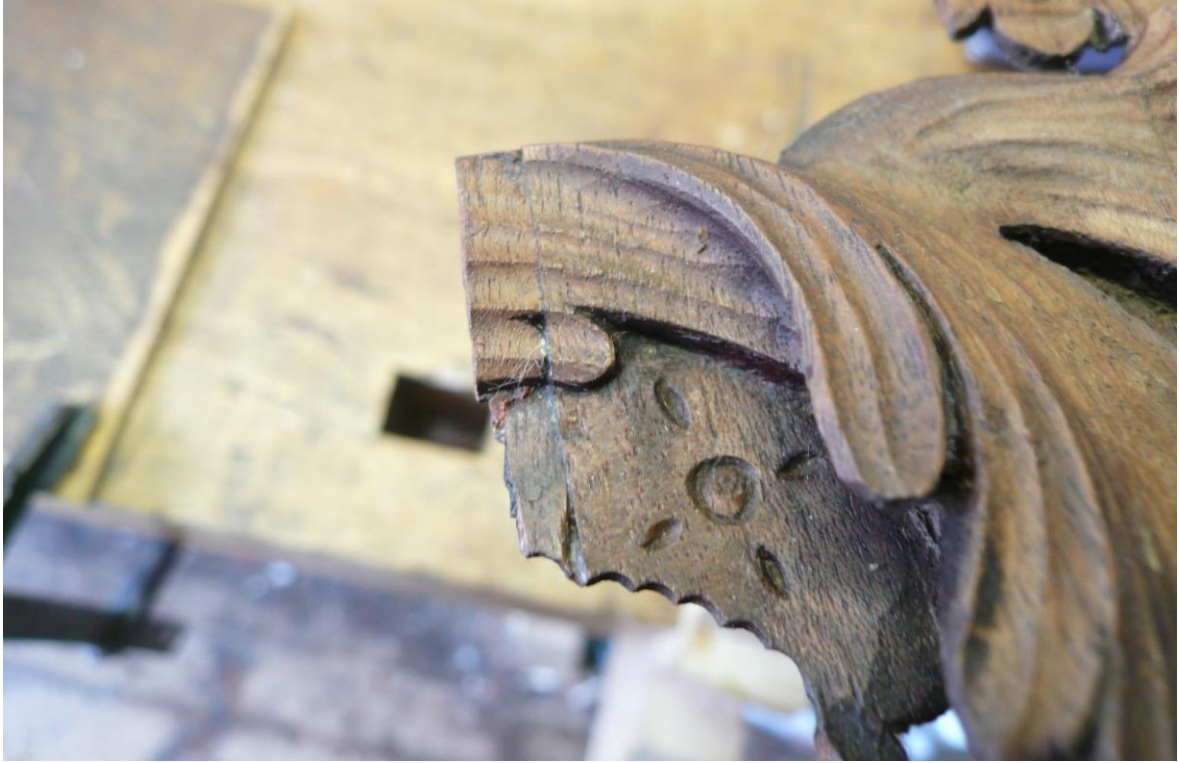
The carved pipe shades were in a bad condition. Old bad repairs had been done with inappropriate glues and were very difficult to get apart again. Sometimes where bits were missing in the past, new bits of carving weren't quite right and the old carved surfaces were compromised to fit the bad matching new bits.

An original fragment with a new piece inappropriately carved (the old piece also re-shaped) and fitted with modern glue

All finish and all non-original bits of wood were removed from the pipe shades, and historic repairs repeated once again. The central pipe shade had a substantial piece of new carving (almost a quarter) which was found to be of inferior quality and not to match the old work. This also was removed and replaced with a newly carved piece.

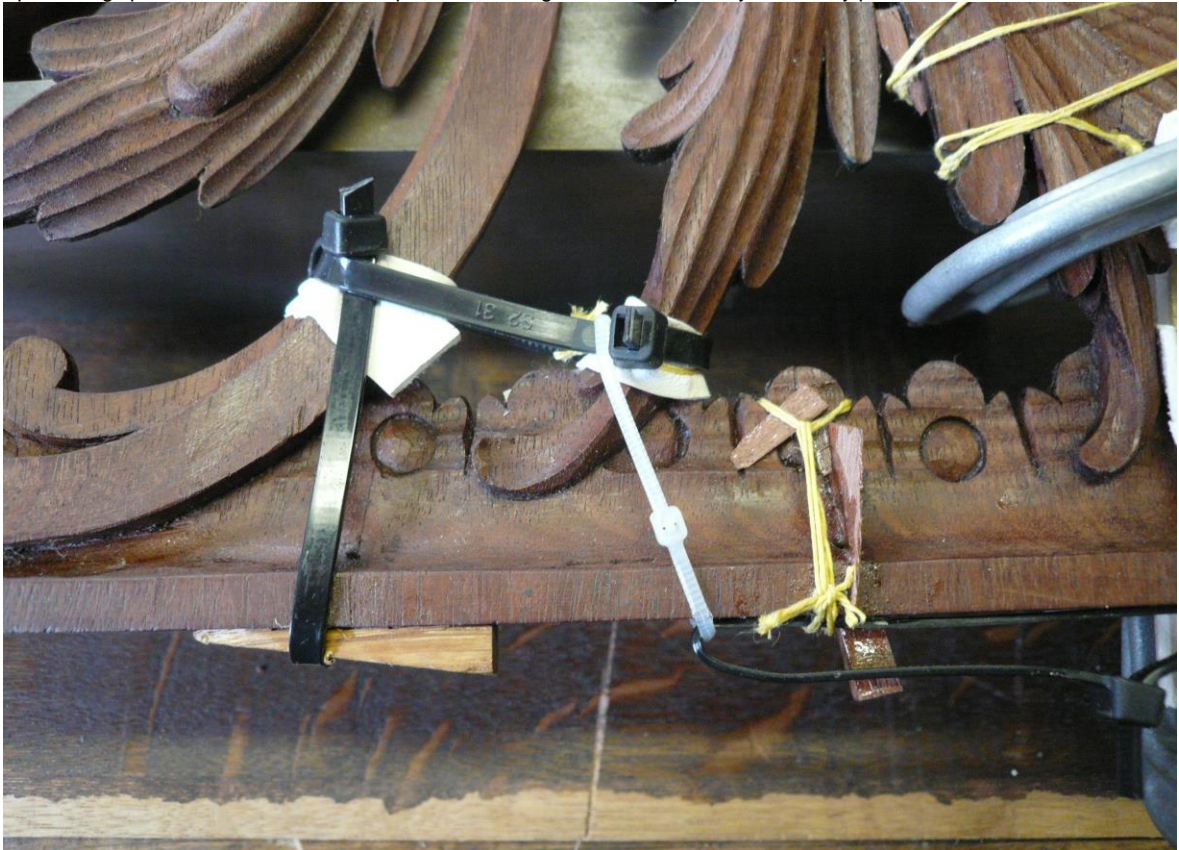
Splits being spliced in with veneer and repaired with hot glue and clamped any which way possible

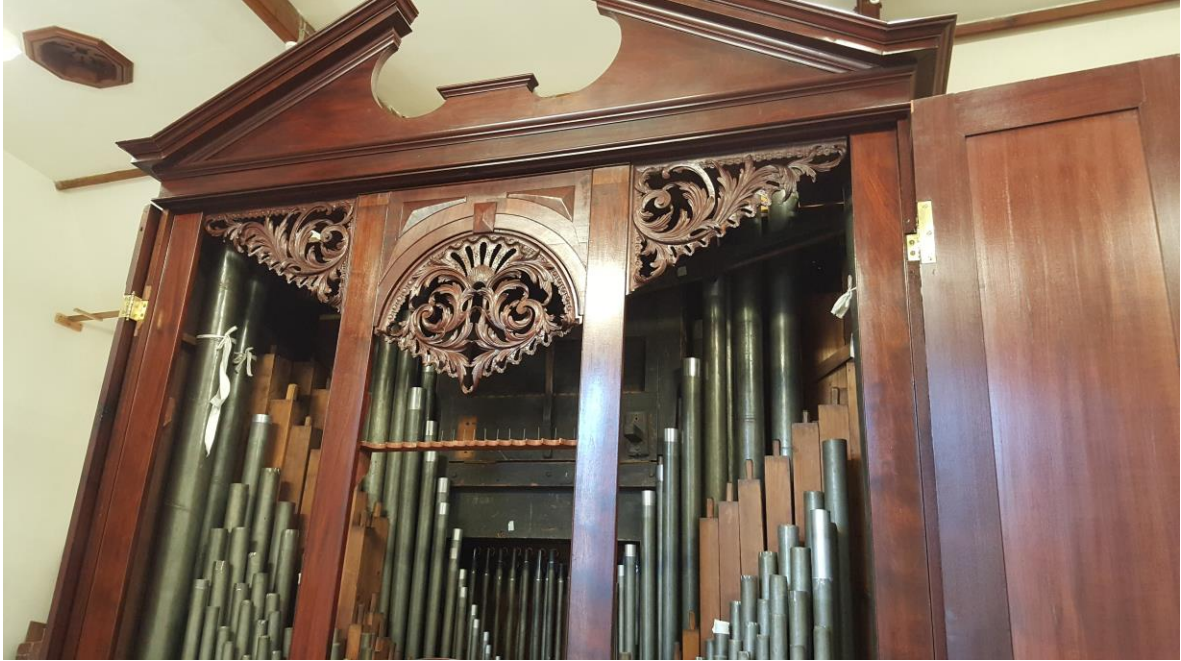
Restored casework still shows the repaired extended uprights. Note the exquisitely restored carvings

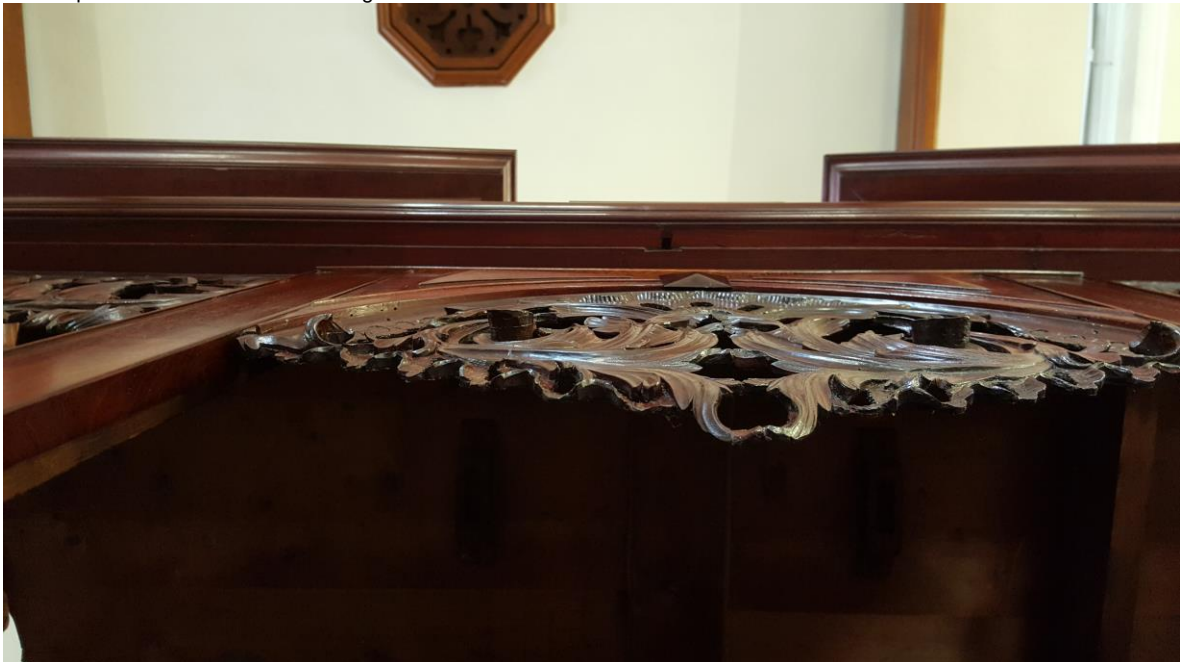
Close-up of the middle section showing the excellent movement in the form
