Case study  
on the restoration  
of the  
1735 Richard Bridge Organ  
at  
Christ Church Spitalfields

Manual & Pedal Soundboards

**WILLIAM DRAKE Ltd**  
Organ Builder  
Chapel Street, Buckfastleigh, Devon TQ11 0AB

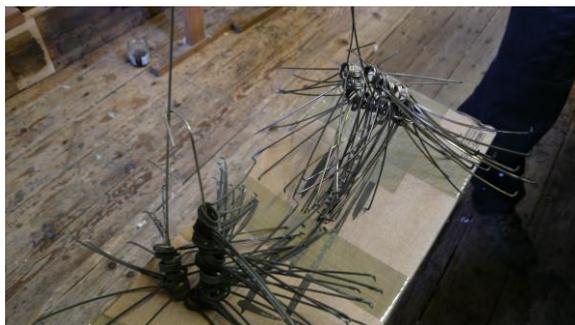
Brass pallet springs (18<sup>th</sup> century?)

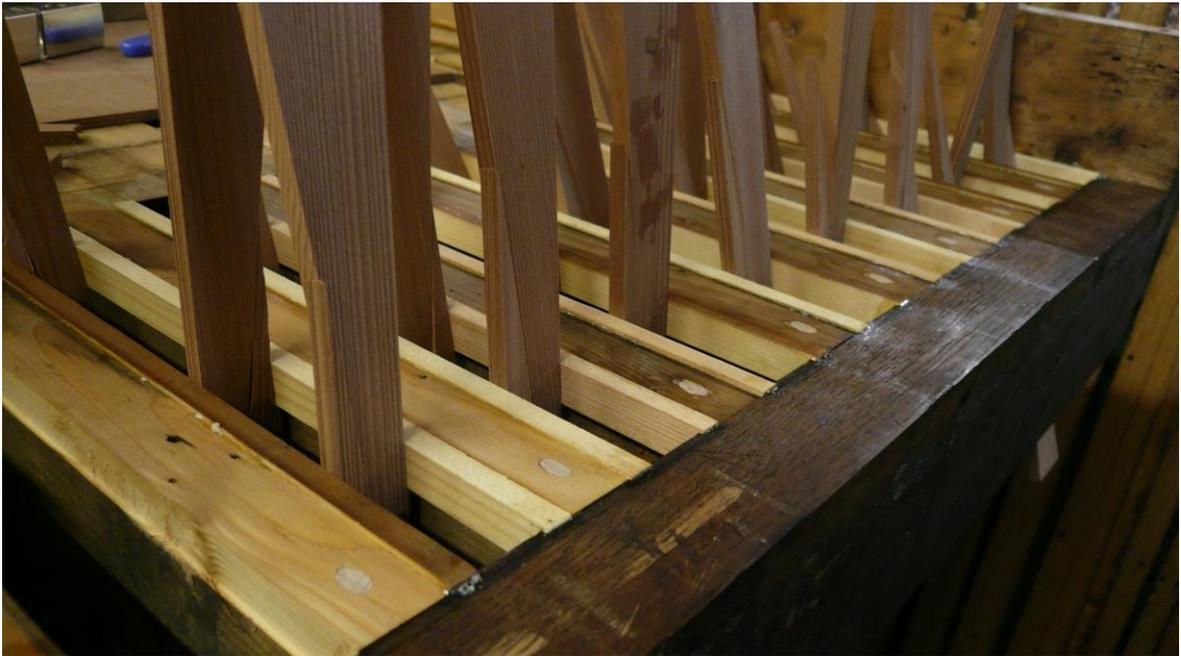
During the dismantling and cleaning of the bottom of the grid, evidence was uncovered that all the pallet slots have at some stage been significantly widened by cutting away the sides of the bars. New wider pallets therefore replace the original ones.

The pieces of pine clamped in position with wedges, allowing the glue to dry

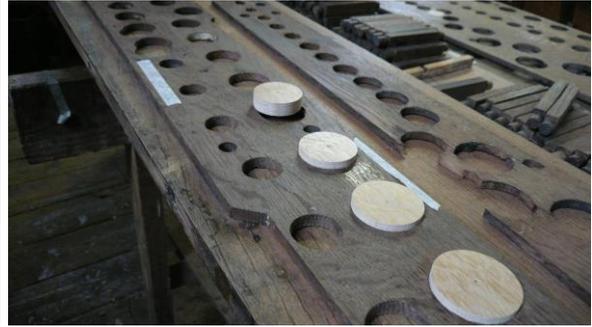
The upperboards and rackboards of the front stops on the soundboard (up to Fifteenth) were found in a reasonably original state.

Great rackboards in hospital (note the rectangular rackpillars)

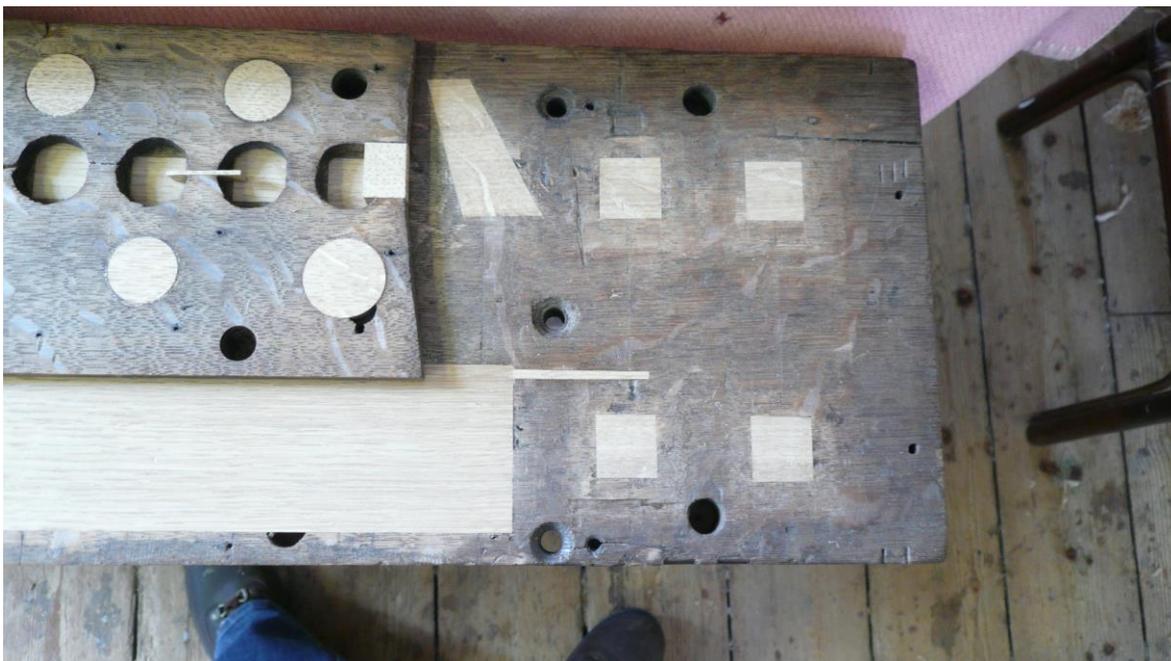
The upperboard for the two Trumpets had possibly been altered the most by Gray & Davison.

One of the two Trumpets was substituted for a two rank mixture, whilst a second trumpet was replaced with a much larger scale Posaune 8'. The both required the need for significant grooving and a veneer on top of the upperboard.

The partly repaired upperboard with rackboard on top

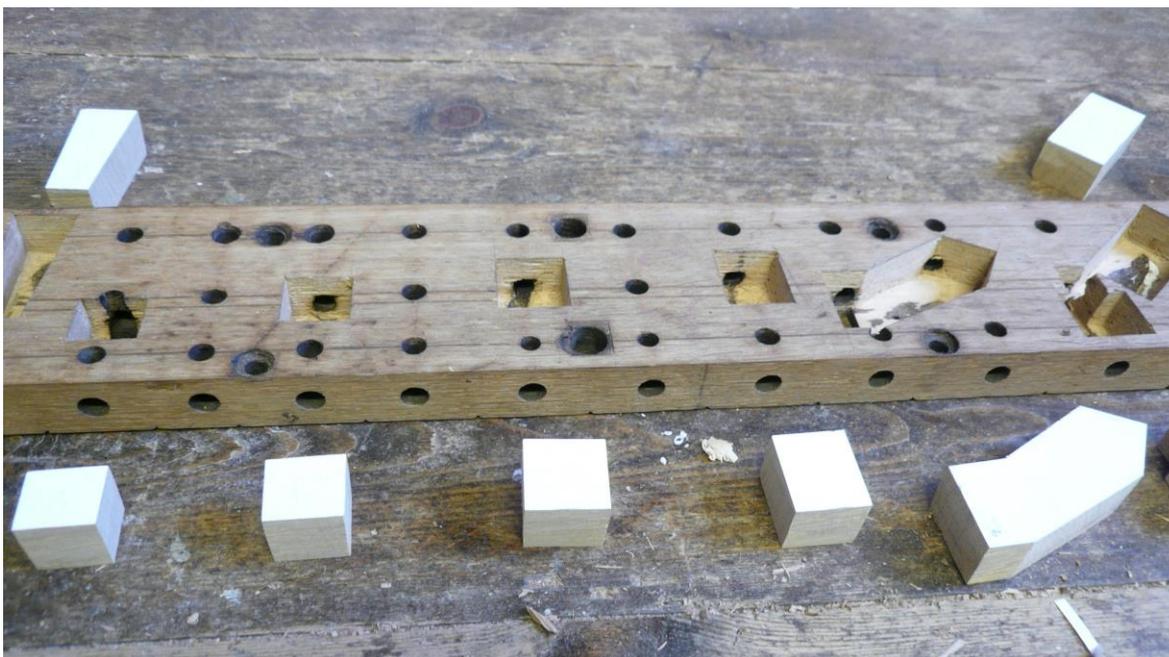
In an early 20<sup>th</sup> century rebuild the furniture and the mixture were replaced with one 16' Bourdon from G ( $10^{2/3}$ ). Each slider would supply every other note in turn. This resulted in the furniture receiving a veneer and large holes and grooves being drilled into it to take the wooden pipe feet.

As can be seen from the above image the cross-drilled holes connecting the three holes of one note are still to be covered, as originally, with a strip of white leather. In the Choir Mixture upperboards these holes are still plugged with the original cork.

Upperboard prepared for the filler pieces to be glued in

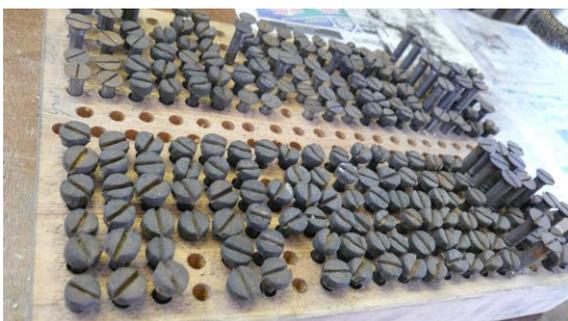
Many of the original upperboard screws have survived (the majority on the Great), but some had been replaced in the 19<sup>th</sup> and 20<sup>th</sup> centuries. All screws went back in exactly the same position as where came from as is essential for hand-made screws. For this purpose a wooden block was made with as many holes as there were screws, so they could be stored in the same relative position on the block as their position on the soundboard.

The screw block containing the Great screws

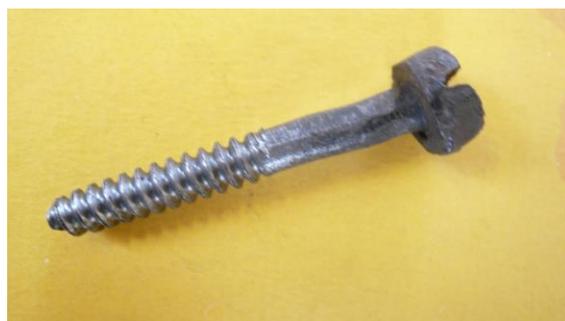
A typical example of a Bridge upperboard screw

The old cheese-head screws have a very rough, uneven underneath of the heads, so every time a screw is tightened up the wood underneath it gets worn away. For the further preservation of the upperboards, thin pipe-metal washers were put under the heads of all the original screw heads.

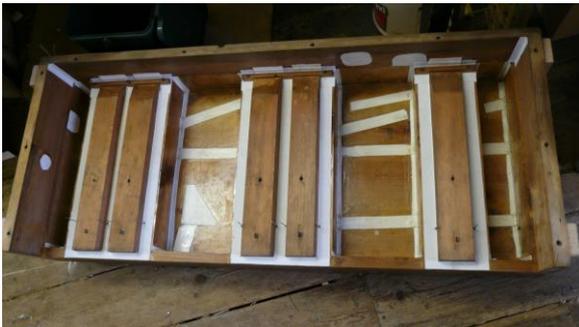
The five-note soundboard showing the very large pallets
